# **Sharon Heritage Conservation District Study**

**Volume III**

# **Individual Property Inventory and Evaluation**

East Gwillimbury, Ontario

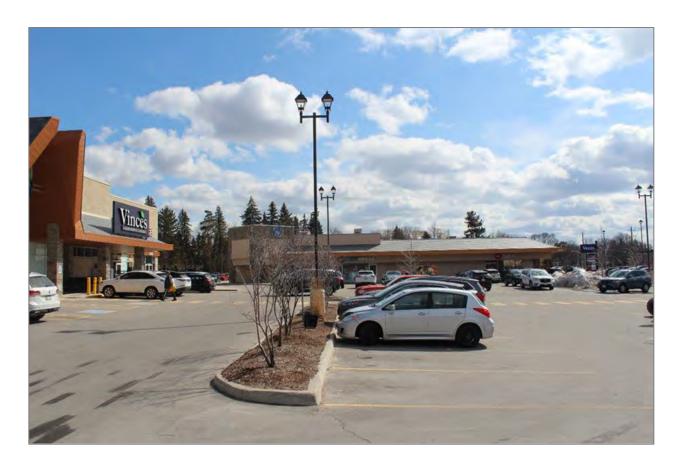
T
Sharon Plaza
N/A
N/A
1978-1988, 2019-2022
Vernacular
Complex
1
Concrete
Concrete – Red Brick
Flat with skirt roof
Rectangular, sash with flat opening and
plain trim. Fixed-pane windows.
Flat, glass sliding door.
N/A
Second building constructed 2019-2020
N/A
Large parking lot.

This is the site of Vince's Market. Vince's Market first opened in Sharon in 1956 in a small building located towards the southwest corner of what is now 19101 Leslie Street. In 1986, a new building was constructed on the property and by 1999 an addition was constructed on the new building. To allow for this development, two residential properties fronting onto Leslie Street between Vince's and Farr Avenue were demolished. By 2019, a second building was constructed on the property. Two additional residential properties, fronting onto Sharon Boulevard, were demolished to allow for this construction. I

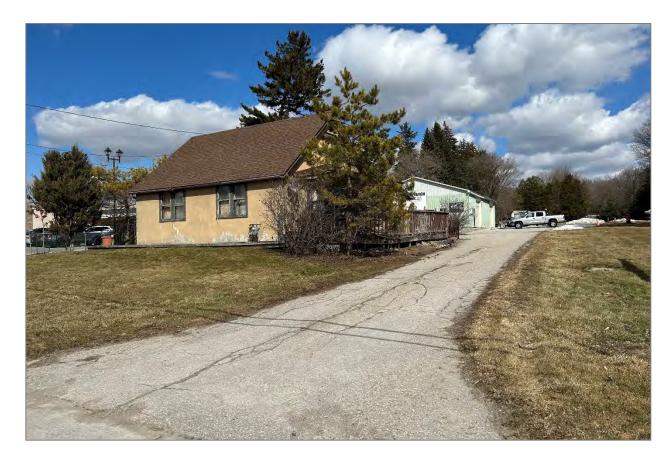
Property Name:	N/A
Roll Number:	N/A
Heritage Status:	N/A
Date:	Pre-1927
Architectural Style /	Vernacular
Influence:	
Floorplan:	Rectangular
Storeys:	1.5
Foundation:	Stone
Main Exterior Walls:	Stucco
Roof:	Side gable
Typical Window:	Rectangular, sash with brown trim
Main Entrance:	Centre Hall
Main Stairs/Porch:	Front – Across Portion
Other Buildings:	Addition; Shed
Landscape Features:	N/A
Other Property	N/A
Features:

#### History The residence on the property, the closest building on the property to Leslie Street, was built before 1927 along with a former shed situated to the rear of **Summary:** the residence. By 1978, a rear addition was added to the residence. By 1988, a new shed was built to the rear of the first identified shed and, by 1995, the first identified shed had been demolished. This property has both a residential and commercial function. N/A Thematic Framework: **Evaluation** This property does not meet any of the criteria for cultural heritage value or interest from O. Reg. 9/06. While the house on this lot is from before 1927, it O. Reg. 9/06 is not oriented facing the street like most in the area and does not share landscape characteristics—such as mature trees in the front yard and along side boundaries that many properties in the rest of the village have. The large, detached garage in the back yard and large parking areas mean this property appears to have a more industrial character than the rest of the Study Area. It therefore does not demonstrate contextual value supporting the character of the district, nor does it have physical, functional, visual or historical links to other properties in the Study Area.

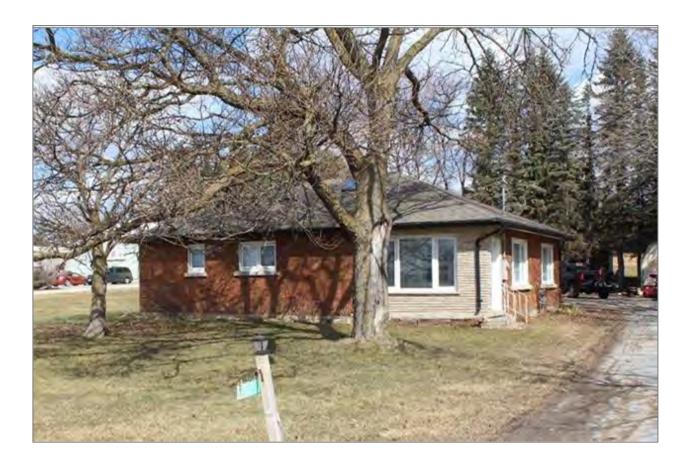
Property Name:	N/A
Roll Number:	N/A
Heritage Status:	N/A
Date:	1954-1960
Architectural Style /	Vernacular
Influence:	
Floorplan:	Square with rear wing addition
Storeys:	1
Foundation:	Concrete
Main Exterior Walls:	Concrete – Red Brick
Roof:	Hipped
Typical Window:	Rectangular, casement with white trim,
	plain concrete lug sill
Main Entrance:	Flat, solid single leaf door
Main Stairs/Porch:	Concrete 2 step porch
Other Buildings:	N/A
Landscape Features:	N/A
Other Property	N/A
Features:

History Summary:	Aerial photographs and satellite images identify that the property was developed between 1954 and 1960. No major alterations have been made to the main building or property since its construction. Several small sheds have been built.  This is a residential property.
Thematic	N/A
Framework:	
Evaluation	This property does not meet any criteria for cultural heritage value or interest
O. Reg. 9/06	from <i>O. Reg. 9/06.</i> While the setback is similar to other properties in the Study Area and the lot includes mature trees in the front yard and along the back property line the house fits a more contemporary suburban character than most of the Study Area and this lot is isolated from properties with similar characteristics.

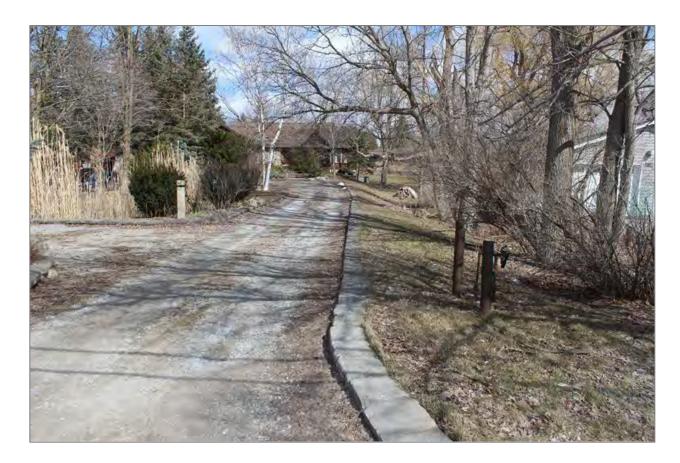
Dronorty Namo:	N/A
Property Name:	
Roll Number:	N/A
Heritage Status:	N/A
Date:	1995-1999
Architectural Style /	Vernacular
Influence:	
Floorplan:	L-Shape
Storeys:	1
Foundation:	Concrete
Main Exterior Walls:	Siding – Wood; Stone veneer
Roof:	Gable
Typical Window:	Unknown
Main Entrance:	Centre Hall
Main Stairs/Porch:	Unknown
Other Buildings:	Small shed to the northwest of the
	main residence.
Landscape Features:	Mature coniferous and deciduous trees
<u> </u>	extend along the property lines
Other Property	Long driveway
Features:

History Summary:	Aerial photographs and satellite images identify that the property was developed between 1995 and 1999. No major alterations have been made to the building or property since its construction.
	This is a residential property.
Thematic	N/A
Framework:	
Evaluation	This property does not meet any of the criteria for cultural heritage value or
O. Reg. 9/06	interest from <i>O. Reg. 9/06</i> . The landscape and location of the house on the lot is different from almost all other properties in the Study Area. While the general size and design of the house appears consistent with other newer homes in the Study Area it is different than the historic character.

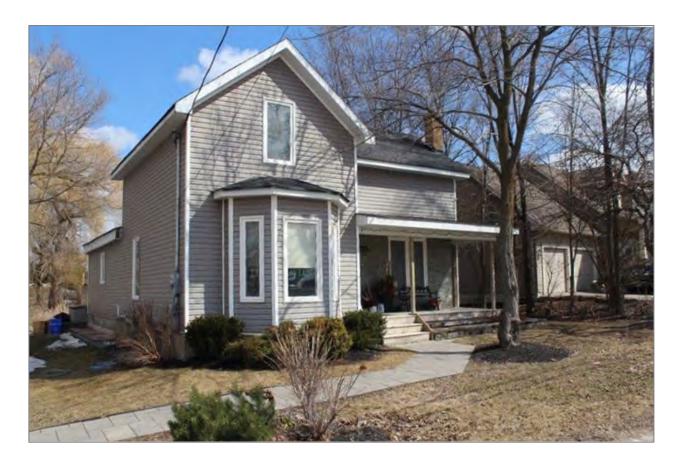
I. Chana
Floorplan:	L-Shape
Storeys:	2
Foundation:	Unknown
Main Exterior Walls:	Siding – Vinyl
Roof:	Cross gable, one brick chimney on the
	building's southeast wall
Typical Window:	Rectangular, casement; large bay
	window with white trim
Main Entrance:	Flat, solid single leaf door with plain
	trim; side Hall
Main Stairs/Porch:	Wood step porch. Shallow sloping shed
·	roof across the primary, east elevation
Other Buildings:	Two car garage with a side gable roof
· ·	located to the north of the main
	residence
Landscape Features:	Mature deciduous and coniferous trees
	extend along the northwest and
	southeast property line. Mature
	deciduous and coniferous trees are also
	located in the front and back yard.
Other Property	N/A

History	Residence of George Kester, a local shoemaker. Aerial photographs and
Summary:	satellite images show that a former addition to the residence was removed by
	1978 and new garage was built to the north of the residence by 1988.
Thematic	N/A
Framework:	
Evaluation	This property meets one criteria—criteria 7—for cultural heritage value or
O. Reg. 9/06	interest from O. Reg. 9/06 because it supports the character of the district.
	The building is in a historic style with a similar setback to many other
	properties in the Study Area.

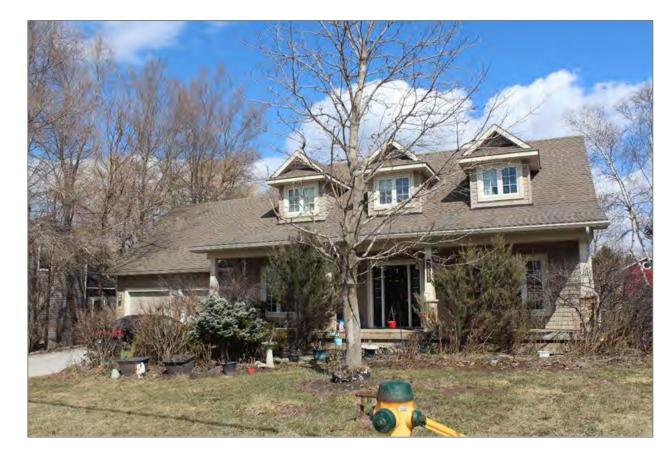
Property Name:	Willson Reid's Shoe Shop
Roll Number:	1954-000-221-325-00
Heritage Status:	Listed, Section 27 Part IV
Date:	Before 1927 (outbuilding) 2007-2009
	(house)
Architectural Style /	Vernacular
Influence:	
Floorplan:	Rectangular with side addition wing
Storeys:	1.5
Foundation:	Stone
Main Exterior Walls:	Siding – Vinyl
Roof:	Gable with pediment gable dormers
	and white trim
Typical Window:	Rectangular, casement with simple trim
Main Entrance:	Flat, solid single leaf door with
	sidelights; center hall
Main Stairs/Porch:	Stone stair. Front – Across Portion.
	Porch roof supported by pyramidal
	columns on pyramidal piers.
Other Buildings:	Outbuilding constructed before 1927
	located to the east of the house. This
	building may be the Willson Reid Shoe
	Shop built c. 1842. It is not visible from
	Leslie Street.
Landscape Features:	Mature deciduous and coniferous trees
	along the northeast, southeast, and
	northwest property lines

History	The outbuilding on the property appears on an aerial photograph from 1927	
Summary:	and it may be associated with Willson Reid. Reid was known to have built a	
	shoe shop c. 1842. The house built between 2007-2009 completely obscures	
	the pre-1927 building from view from Leslie Street.	
	A Willson Reid was identified as a tanner and possibly owner of a marble	
	factory. There was a Willson Reid that was a founding member of the	
	Anglican Church, Deputy Reeve in 1868, and one of the first school trustees in	
	1858. <sup>iv</sup>	
Thematic	Political	
Framework:		
Evaluation	This property meets criterion 4 of O. Reg. 9/06 for its direct historical	
O. Reg. 9/06	connection to Willson Reid.	
	I

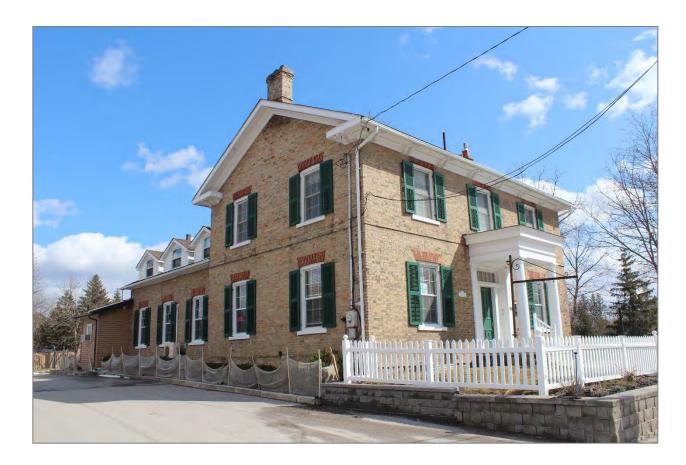
Roll Number: 1954-000-221-320-00 Heritage Status: Listed, Section 27 Part IV  Date: 1857 Architectural Style / Influence: Rectangular with rear wing addition Storeys: 2 Foundation: Stone Main Exterior Walls: Brick – Buff Brick/Polychrome Roof: Side gable with return eaves and simp wooden brackets and two brick
Heritage Status:  Date:  1857  Architectural Style / Classical Revival Influence:  Floorplan: Rectangular with rear wing addition Storeys: 2  Foundation: Stone Main Exterior Walls: Brick – Buff Brick/Polychrome Roof: Side gable with return eaves and simp
Date: 1857  Architectural Style / Classical Revival Influence: Rectangular with rear wing addition Storeys: 2  Foundation: Stone Main Exterior Walls: Brick – Buff Brick/Polychrome Roof: Side gable with return eaves and simp
Architectural Style / Influence:  Floorplan: Rectangular with rear wing addition Storeys: 2  Foundation: Stone  Main Exterior Walls: Brick – Buff Brick/Polychrome Roof: Side gable with return eaves and simp

The residence was first built for Edward Brammer in 1857. Brammer was a member of the Children of Peace and took part in the 1837 Rebellion, for which he was jailed for a short period. Brammer was a blacksmith in Sharon. This property is also referred to as the 'Doctor's House' because bottles, pestles, and mortars have been found on the property and peoples' names have been scratched into the brick. The front porch and pillars may have been a later addition. vi An addition was also added to the building's east elevation between 1946 and 1954.

Thematic	Political
Framework:	Religious/Social Development
Evaluation	This property meets six of the criteria from O. Reg. 9/06, including 1, 4, 6, 7, 8
O. Reg. 9/06	and 9. The property is a rare and representative example of a regional
	variation of the Classical Revival architectural style. It may demonstrate a high
	level of craftsmanship. It is associated with people significant in the 19 <sup>th</sup>
	century community and was designed by prominent local architect John T.
	Stokes. The property supports the character of the district. It has historical
	and visual links to other surrounding historic buildings -such as being built
	around the same time as the Judah Doan House –across the street—with
	similar brick. It is in a prominent location in town and with the Judah Doan
	house serves as a gateway building and landmark.

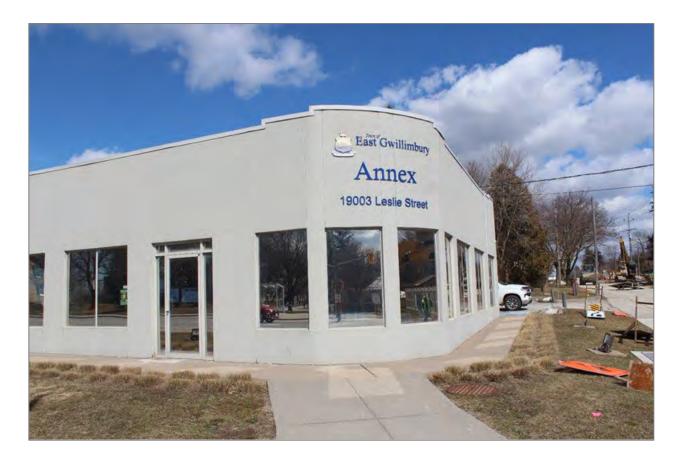
Property Name:	Town Hall Annex
Roll Number:	N/A
Heritage Status:	N/A
Date:	1946-1953
Architectural Style /	Vernacular
Influence:	
Floorplan:	Square
Storeys:	1
Foundation:	Concrete
Main Exterior Walls:	Stucco
Roof:	Flat with short parapet near the
	primary entrance on the building's
	south corner
Typical Window:	Rectangular, fixed pane with no trim
Main Entrance:	Glazed single leaf door with transom
	and sidelights; centre Hall
Main Stairs/Porch:	N/A
Other Buildings:	N/A
Landscape Features:	Mature deciduous trees extend along
	the northeast property line and are
	intermittently located along the
	northwest property line
Other Property	Large parking lot
Features:

History Summary:	Aerial photographs and satellite images identify that the current building on the property was constructed between 1946 and 1954. Prior to the present
	use, the property appears to have been used as a field and as residential and commercial land. In 1927, the northern half of the lot had a small building,
	and the southern half of the lot was a field. This property is in Lot 3, Concession 11 and was therefore possibly farmed by Job or Amos Hughes. By 1954, two buildings, one fronting onto Leslie Street and one fronting onto
	Mount Albert Road, had been constructed on the southern half of the property. Between 1995 and 1999, all three former buildings were
	demolished, leaving only the present building.
Thematic	N/A
Framework:	
Evaluation	This property does not meet any of the criteria from O. Reg. 9/06.
O. Reg. 9/06

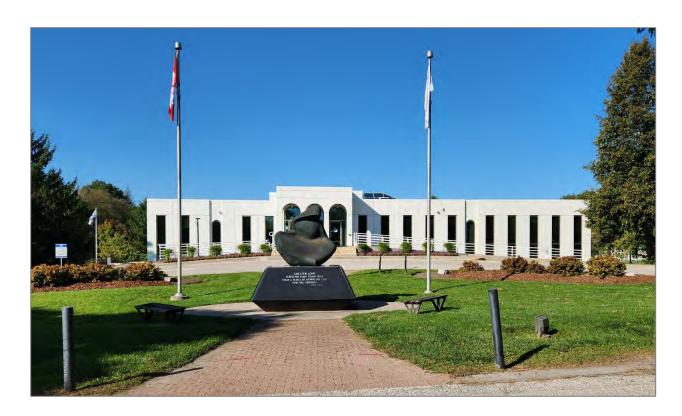
Property Name:	Town of East Gwillimbury Civic Centre
Roll Number:	N/A
Heritage Status:	N/A
Date:	1990
Architectural Style /	Contemporary
Influence:	
Floorplan:	Irregular
Storeys:	1
Foundation:	Concrete
Main Exterior Walls:	Stucco
Roof:	Flat, glazed hip
Typical Window:	Rectangular with plain trim
Main Entrance:	Flat with several glazed single leaf
	doors with single light, semi-circular
	transom
Main Stairs/Porch:	Concrete 4 step leading to arcaded
	front porch with three arches
Other Buildings:	Small shed to the west of the main
	building's northwest corner
Landscape Features:	Cenotaph, extensive landscaping to the
	northeast and southeast of the
	building, and mature coniferous and
	deciduous trees lining parts of the
	northwest and southeast property lines
Other Property	Large parking lot in the southwest
Features:	corner of the property

History	Civic Centre for the Town of East Gwillimbury built in 1990. This property is in
Summary:	Concession 2, Lot 11. In 1857 Joseph Sutherland was the owner of the land. By 1860 Judah Doan owned it. This property appears to have been used as a field until its development in 1990. The cenotaph to the east of the building was installed in 1990 and the Low Impact Development Garden was installed by 2017.
	This is an institutional property.
Thematic	Political
Framework:	
Evaluation	This property meets three criteria of O. Reg. 9/06, including 1, 4 and 9. It has
O. Reg. 9/06	design value as a unique example of a civic building in the area. It has associative value because of a direct connection to the political theme for the community. It has contextual value as a landmark.

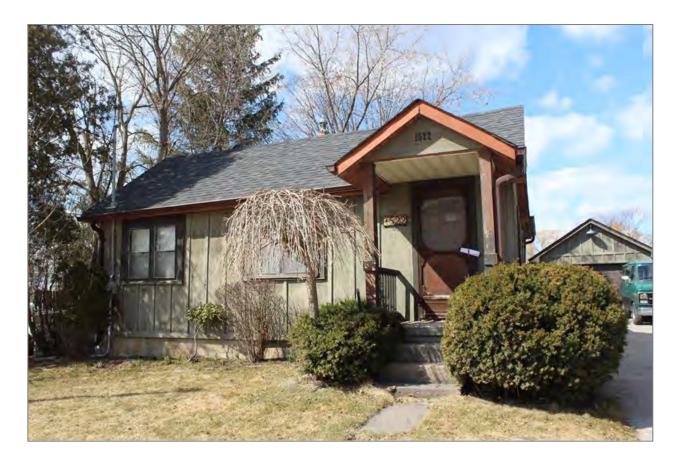
Property Name:	N/A
Roll Number:	N/A
Heritage Status:	N/A
Date:	1946-1953
Architectural Style /	Vernacular, minimal traditional
Influence:	
Floorplan:	Rectangular
Storeys:	1
Foundation:	Unknown
Main Exterior Walls:	Wood board and batten siding
Roof:	Cross gable
Typical Window:	Rectangular, sash with wooden trim
Main Entrance:	Flat, solid single leaf door with plain
	trim; side hall
Main Stairs/Porch:	Concrete 4 step porch covered by a
	front gable roof supported by wooden
	posts
Other Buildings:	Garage to the northeast of the main
	building
Landscape Features:	Mature deciduous and coniferous trees
	extend along the northwest and
	southwest property lines
Other Property	N/A
Features:

History Summary:	This property is on Lot 11 Concession 3. In 1860 Job Hughes was the owner of the land. This property appears to have been used as a field. Aerial photographs and satellite images do not show any buildings or structures on the property until 1954. They do show rows of crops. A large shed was constructed on the property by 1970.  This is a residential property.
Thematic	N/A
Framework:	
Evaluation O. Reg. 9/06	This Property meets criteria 7 of <i>O. Reg. 9/06</i> . It has contextual value because it supports the character of the district.

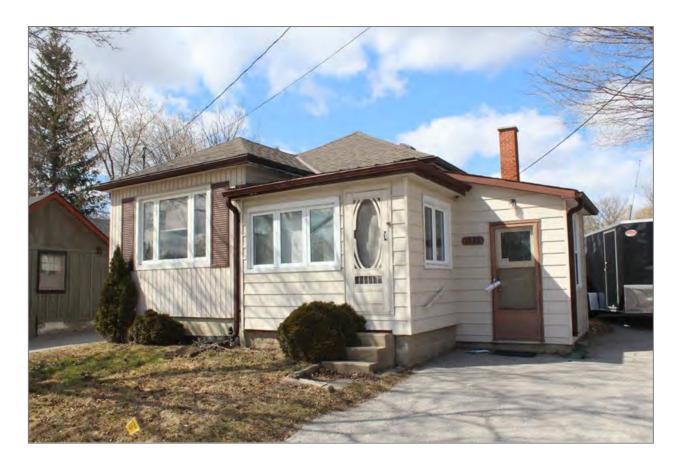
Property Name:	N/A
Roll Number:	N/A
Heritage Status:	N/A
Date:	1946-1953
Architectural Style /	Vernacular, minimal traditional
Influence:	
Floorplan:	Square with wide wing addition
Storeys:	1
Foundation:	Concrete - Brick
Main Exterior Walls:	Siding – Vinyl
Roof:	Hipped with red brick chimney
Typical Window:	Rectangular, casement with white trim
	and decorative storm shutters
Main Entrance:	Flat, solid single leaf door with simple
	trim; side hall
Main Stairs/Porch:	Concrete 3 step entrance
Other Buildings:	Shed to the north of the main building
Landscape Features:	Mature deciduous trees interspersed
	throughout the property
Other Property	N/A
Features:

History Summary:	This property is on Lot 11 Concession 3. In 1860 Job Hughes was the owner of the land. By 1878 Amos Hughes owned it. This lot was likely the location of Amos Hughes' house and farm. Amos Hughes served as both Township clerk and liquor licence inspector. Hughes was also a member of the Children of Peace. The 19 <sup>th</sup> century house appears to have been removed by 1927. The current house was built by 1953.  This is a residential property.
Thematic	N/A
Framework:	
Evaluation	This Property meets criteria 7 of O. Reg. 9/06. It has contextual value because
O. Reg. 9/06	it supports the character of the district.

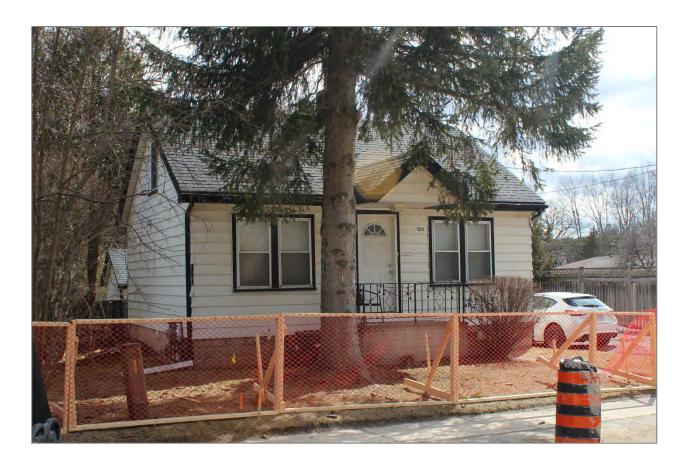
Property Name:	N/A
Roll Number:	N/A
Heritage Status:	N/A
Date:	1927-1946
Architectural Style /	Vernacular; Minimal Traditional
Influence:	
Floorplan:	Rectangular
Storeys:	1.5
Foundation:	Rusticated Concrete Block
Main Exterior Walls:	Siding – Wood
Roof:	Side gable
Typical Window:	Rectangular, sash with plain trim
Main Entrance:	Flat, single leaf door with central
	glazing
Main Stairs/Porch:	Concrete 4 stair porch covered by a
	small gable roof
Other Buildings:	Shed to the south of the main building
Landscape Features:	Mature deciduous and coniferous trees
	interspersed throughout the property
Other Property	N/A
Features:

Aerial photographs clearly show a house on this lot by 1946. The 1927 photo is unclear but does not appear to show a building on this lot. Furthermore, rusticated concrete block –used for the foundation—was developed in the late 19<sup>th</sup> century and was popular in Ontario from around 1905 to 1930.

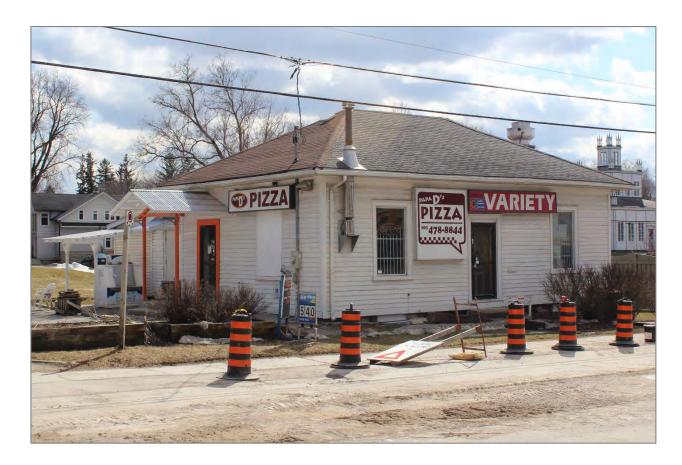
<u> </u>
Property Name:	Mary Jane Rowan House / John Terry
	House
Roll Number:	1954-000-221-982-00
Heritage Status:	N/A
Date:	1860
Architectural Style /	Vernacular
Influence:	
Floorplan:	Rectangular with rear wing addition
Storeys:	1
Foundation:	Unknown
<b>Main Exterior Walls:</b>	Siding – Vinyl
Roof:	Hipped
Typical Window:	Rectangular, casement with white trim
Main Entrance:	Flat, single leaf door with simple trim;
	centre hall
Main Stairs/Porch:	Concrete 3 step entrance
Other Buildings:	Addition
Landscape Features:	Mature deciduous and coniferous trees
	intermittently extend along the
	southeast and southwest property lines
Other Property	N/A
Features:

History Summary:	Residence of John Terry. The Newmarket Era said that he had taken "quite an active part in politics on the liberal side" and worked as a Town Collector in 1840. Terry was also a member of the Children of Peace. Mary Jane Rowen was not connected with Peter Rowan. Aerial photographs and satellite images do not show any major alterations on the property from 1927 to the present.  This is a commercial property that formerly served a residential purpose.
Thematic	N/A
Framework:	
Evaluation	This Property meets criteria 7 of O. Reg. 9/06. It has contextual value because
O. Reg. 9/06	it supports the character of the district.

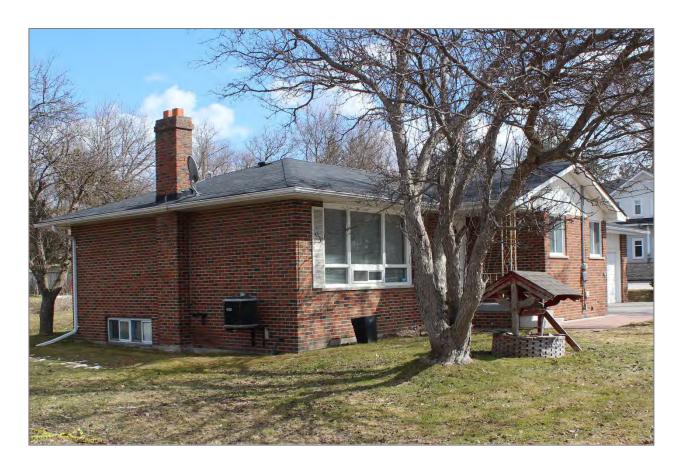
N/A
N/A
N/A
1960-1969
Vernacular
Rectangular
1
Concrete
Concrete – Red Brick
Complex with red brick chimney on the
building's northwest wall
Rectangular, casement with simple trim
and plain lug sill
Flat, single leaf with central glazing with
plain trim; side hall
Concrete 3 riser porch covered by the
main roof.
N/A
Mature deciduous trees interspersed
across the property
N/A

History	This property is on Lot 10 Concession 3. In 1860 Elijah Mack was the owner of	
Summary:	the land. By 1860 David Willson owned it. By 1878 Robert Coates owned it. Aerial photographs and satellite images identify that this property was part of a field prior to its development in the 1960s.	
	This is a residential property.	
Thematic	N/A	
Framework:		
Evaluation	This property does not meet any of the criteria from O. Reg. 9/06. The house	
O. Reg. 9/06	reflects the period of suburban development in the area, different from the	
	village character of most of the Study Area.

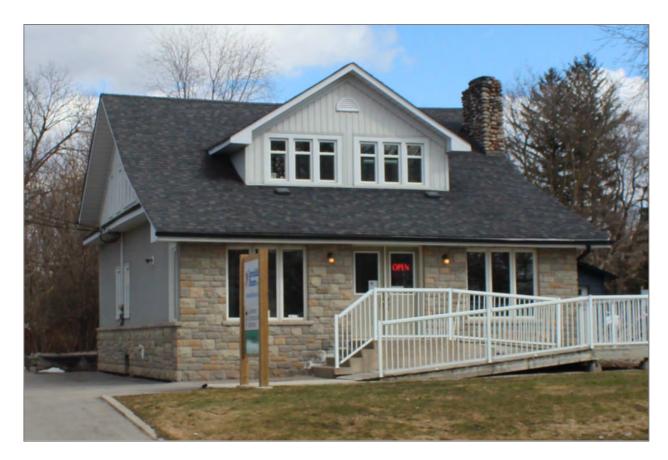
N/A
N/A
N/A
Pre-1927
Vernacular; Arts and Crafts
Rectangular
1.5
Unknown
Siding – Stone veneer & vinyl
Gable with catslide, central gable, &
stone chimney
Rectangular, casement with white trim
and concrete lug sill.
Flat, double leaf door both with central
glazing with simple trim; centre hall
Concrete 4 step porch also accessible
via a ramp.
N/A
Mature deciduous and coniferous trees
interspersed across the property
N/A

History Summary:	This property is on Lot 10 Concession 3. In 1860 Elijah Mack was the owner of the land. By 1860 David Willson owned it. By 1878 Robert Coates owned it. The house on this lot appears to be present on the 1927 aerial photograph of the property. It appears to have been substantially modified over time.	
	This is a commercial property that formerly served a residential purpose.	
Thematic Framework:	N/A	
Evaluation O. Reg. 9/06	This property does not meet any of the criteria from O. Reg. 9/06.

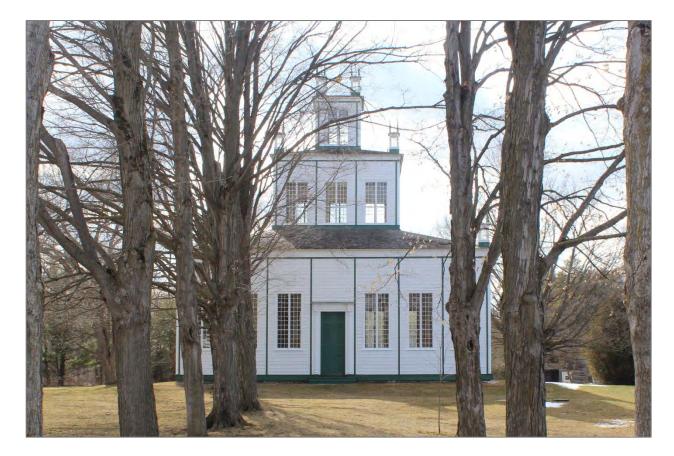
Property Name:	Sharon Temple
Roll Number:	1954-000-220-444-00
Heritage Status:	Listed, Section 27 Part IV
Date:	1825-1832
Architectural Style /	Neo-classical influences
Influence:	
Floorplan:	Square
Storeys:	3
Foundation:	Unknown
Main Exterior Walls:	Wood siding
Roof:	Interrupted pyramidal
Typical Window:	Rectangular, sash, multi-pane
Main Entrance:	Flat, solid single leaf door
Main Stairs/Porch:	N/A
Other Buildings:	N/A
Landscape Features:	Mature deciduous trees flank the
	pathway leading to the northeast
	entrance. Mature deciduous trees are
	intermittently placed around the
	building
Other Property	N/A
Features:

This elegant structure stands as testament to the faith and good works of the Children of Peace. In 1825-1832 master carpenters
Ebenezer and John Doan constructed it to the plans of religious leader David Willson who was inspired by Biblical descriptions of Solomon's Temple and the New Jerusalem. The square plan symbolized the sect's egalitarian beliefs and cooperative principles. Once a month and on holidays the Temple was the scene of music-filled ceremonies. Its rescue from demolition in 1918 by the York Pioneer and Historical Society is an early example of historic conservation in Canada.<sup>ix</sup>

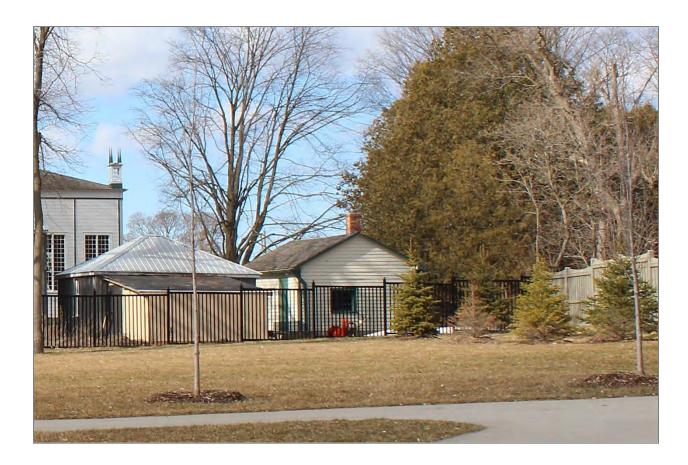
Property Name:	Cookhouse
Roll Number:	1954-000-220-444-00
Heritage Status:	Listed, Section 27 Part IV
Date:	c. 1840
Architectural Style /	Ontario Vernacular
Influence:	
Floorplan:	Rectangular
Storeys:	1
Foundation:	N/A
Main Exterior Walls:	Wood clapboard siding
Roof:	Front gable
Typical Window:	N/A
Main Entrance:	Flat, solid single leaf door
Main Stairs/Porch:	N/A
Other Buildings:	N/A
Landscape Features:	Mature deciduous tree are situated to
	the building's northeast
Other Property	N/A
Features:

History	Cookhouse used by the Children of Peace to prepare food for feasts. Two	
Summary:	feasts were held each year, one in June in celebration of David Willson's	
	birthday and one in September to celebrate Illumination. The building was	
	moved to its current location in 1978 and restored over the course of two	
	years. Some of the materials used in the restoration of the building were	
	taken from David Willson's residence.xiii	
Thematic	Religious – Social Development	
Framework:		
Evaluation	This building meets two criteria from O. Reg. 9/06, including 4 and 8. It has	
O. Reg. 9/06	historical links with the Children of Peace and is physically linked to the rest	
	of the buildings as part of the Sharon Temple Museum complex.

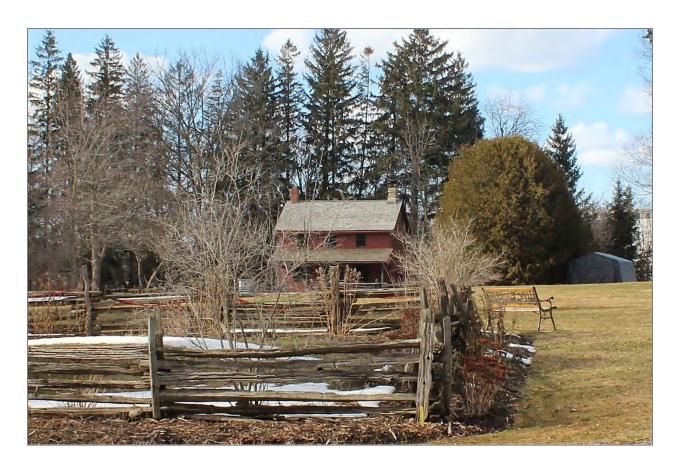
History	Ebenezer Doan, member of the Children of Peace and master builder of
Summary:	Sharon Temple, and his wife, Elizabeth, lived in this house. It was moved to its
	current location and restored in 1958.xiv
Thematic	Religious – Social Development
Framework:	
Evaluation	This house meets three criteria from <i>O. Reg. 9/06</i> , including 1, 4 and 8. It has
O. Reg. 9/06	physical value as a rare and early example of a frame house in the area. It has
	historical links with Ebenezer Doan. It is physically linked to the rest of the
	buildings as part of the Sharon Temple Museum complex.

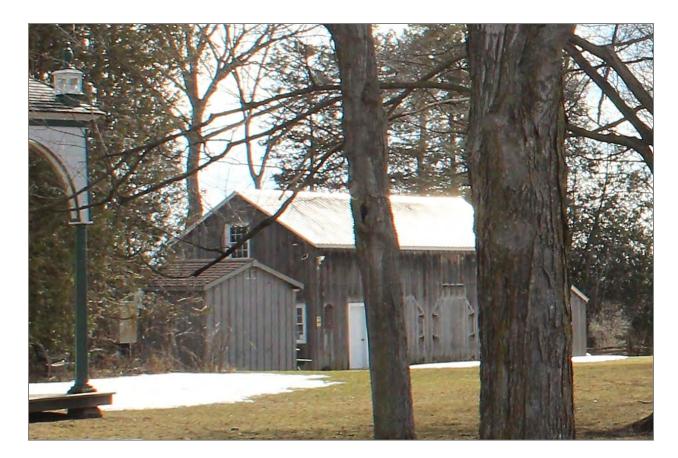
Г.
Property Name:	Ebenezer Doan Granary
Roll Number:	1954-000-220-444-00
Heritage Status:	Listed, Section 27 Part IV
Date:	c. 1820
Architectural Style /	Ontario Vernacular
Influence:	
Floorplan:	Rectangular
Storeys:	1
Foundation:	N/A
Main Exterior Walls:	Wood siding
Roof:	Front gable
Typical Window:	N/A
Main Entrance:	Flat, single leaf sliding barn door with
	central window
Main Stairs/Porch:	N/A
Other Buildings:	Small shed to the building's southwest
Landscape Features:	Building surrounded on all sides by
	mature deciduous and coniferous trees
Other Property	N/A
Features:

History	Built by Ebenezer Doan, member of the Children of Peace, and used for
Summary:	storage. The drive shed was built first, circa 1820 and the granary was built in
	the 1830s. The drive shed was relocated to its current location by 1970.xv
Thematic	Religious – Social Development
Framework:	
Evaluation	This building meets three criteria from O. Reg. 9/06, including 1, 4 and 8. It
O. Reg. 9/06	has physical value as a rare and early example of a agricultural building in the
	area. It has historical links with Ebenezer Doan. It is physically linked to the
	rest of the buildings as part of the Sharon Temple Museum complex.

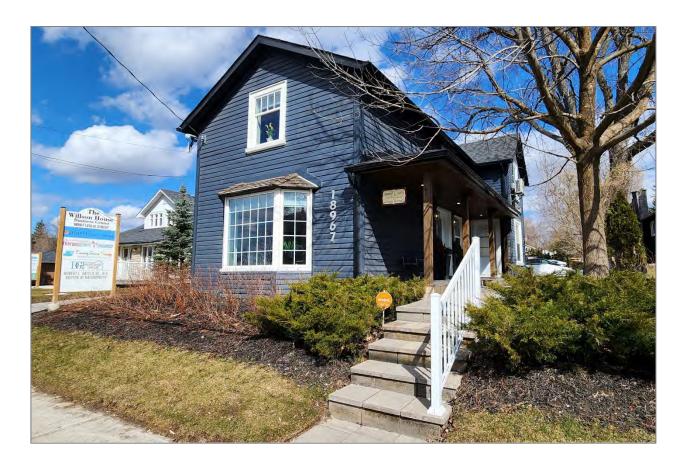
-	
Property Name:	John D. Graham House
Roll Number:	1954-000-221-284-00
Heritage Status:	Listed, Section 27 Part IV
Date:	1856
Architectural Style /	Vernacular
Influence:	
Floorplan:	L-Shape with addition
Storeys:	1.5
Foundation:	Unknown
Main Exterior Walls:	Siding – Wood
Roof:	Side gable with chimney
Typical Window:	Rectangular, sash with white trim, 6/6
	window
Main Entrance:	Flat, single leaf door with central
	glazing; center hall
Main Stairs/Porch:	Wood 1 step porch along part of the
	southeast elevation. Hipped porch roof
	supported with square posts
Other Buildings:	Garage to the northwest of the main
	building
Landscape Features:	Mature deciduous and coniferous trees
	line the southeast, part of the
	northwest, and part of the northeast
	elevation; garden towards the
	northeast property line
Other Property	N/A
Features:

History Summary:	Residence of John D. Graham. Graham was a member of the Children of Peace and was imprisoned for his participation in the 1837 rebellion. *vi The rear section of the residence was rebuilt c. 1898. *vii The property was used for residential purposes until 2021, when it transitioned to commercial use. Aerial photographs and satellite images show that a large parking lot was built to the rear of the main building alongside its commercial transition.
	This is a commercial property that formerly served a residential purpose.
Thematic Framework:	Political
Evaluation O. Reg. 9/06	This property meets two of the criteria from <i>O. Reg. 9/06</i> . It meets criteria 4 and 7. It has historical value because it was the residence of John D. Graham a significant person in the early history of the village who was also a member of the Children of Peace. It has contextual value because it supports the character of the area.

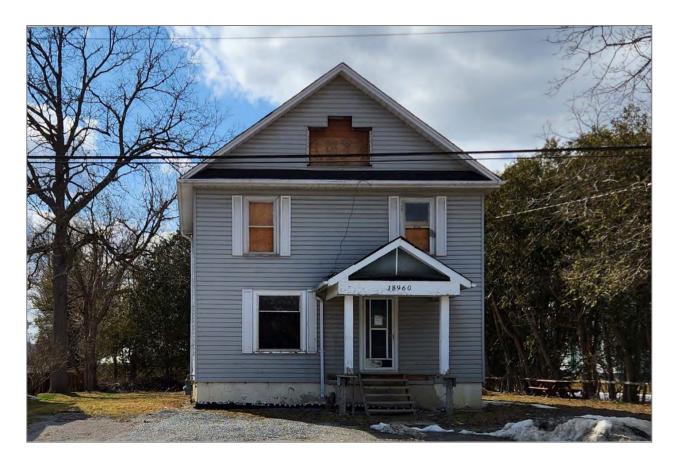
Roll Number: 1954-000-220-442-00 Heritage Status: Listed, Section 27 Part IV  Date: c. 1913 Architectural Style / Influence: Floorplan: Rectangular Storeys: 2.5 Foundation: Unknown Main Exterior Walls: Vinyl siding Roof: Front gable with overhanging eave and pedimented eave  Typical Window: Rectangular, sash, plain trim with decorative storm shutter  Main Entrance: Flat, single leaf door with central glazing  Main Stairs/Porch: Wood 6 step porch with front gable roof supported by square wooden posts  Other Buildings: N/A  Landscape Features: Mature deciduous trees line the northwest and southwest property lines  Other Property N/A		
Heritage Status:  Date:  c. 1913  Architectural Style / Influence: Floorplan:  Rectangular  Storeys:  2.5  Foundation:  Unknown  Main Exterior Walls:  Vinyl siding  Roof:  Front gable with overhanging eave and pedimented eave  Typical Window:  Rectangular, sash, plain trim with decorative storm shutter  Main Entrance:  Flat, single leaf door with central glazing  Main Stairs/Porch:  Wood 6 step porch with front gable roof supported by square wooden posts  Other Buildings:  N/A  Landscape Features:  Mature deciduous trees line the northwest and southwest property lines	Property Name:	Julia Brown House

History	Residence of Julia Brown, of whom little is known. Aerial photographs and
Summary:	satellite images identify that no alterations to the property have been made
	on the property from 1927 to the present.
Thematic	N/A
Framework:	
Evaluation	This property meets criteria 7 from O. Reg. 9/06. It has contextual value
O. Reg. 9/06	because it supports the character of the area.

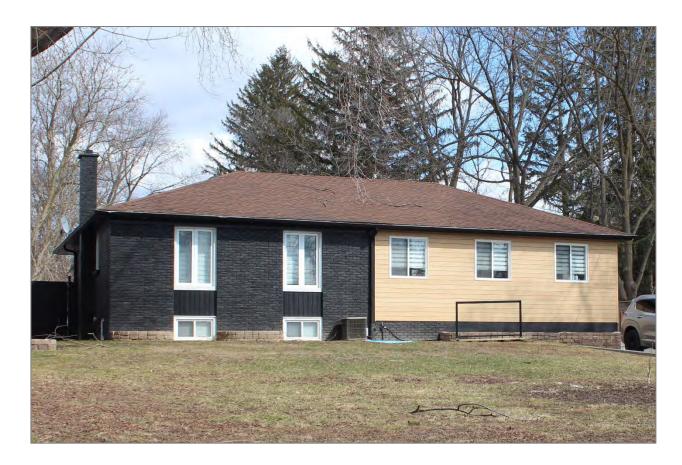
Roll Number: N/A  Heritage Status: N/A  Date: 1954-1969  Architectural Style / Influence: Rectangular with rear wing addition  Storeys: 1  Foundation: Concrete  Main Exterior Walls: Concrete – Red Brick  Roof: Hipped  Typical Window: Rectangular, casement with white trim  Main Stairs/Porch: Unknown; centre Hall  Main Stairs/Porch: Unknown  Other Buildings: Shed to the northeast of the main residence  Landscape Features: Mature deciduous and coniferous trees line the northeast, southeast, and northwest property lines  Other Property Features: N/A		т.
Heritage Status: N/A  Date: 1954-1969  Architectural Style / Vernacular, Ranch Influence: Rectangular with rear wing addition  Storeys: 1  Foundation: Concrete  Main Exterior Walls: Concrete – Red Brick  Roof: Hipped  Typical Window: Rectangular, casement with white trim  Main Entrance: Unknown; centre Hall  Main Stairs/Porch: Unknown  Other Buildings: Shed to the northeast of the main residence  Landscape Features: Mature deciduous and coniferous trees line the northeast, southeast, and northwest property lines  Other Property N/A	Property Name:	N/A

History	This property is on Lot 10 Concession 3. In 1860 Elijah Mack was the owner of
Summary:	the land. By 1860 David Willson owned it. By 1878 Robert Coates owned it. Aerial photographs and satellite images identify that this property was part of a field prior to its development. By 1927, a large shed occupied the property, located slightly northeast of the current building's location. The shed was demolished by 1970. A rear addition was constructed on the present building by 2005.  This is a commercial property that formerly served a residential purpose.
Thematic	N/A
Framework:	
Evaluation	This property does not meet any of the criteria of O. Reg. 9/06.
O. Reg. 9/06

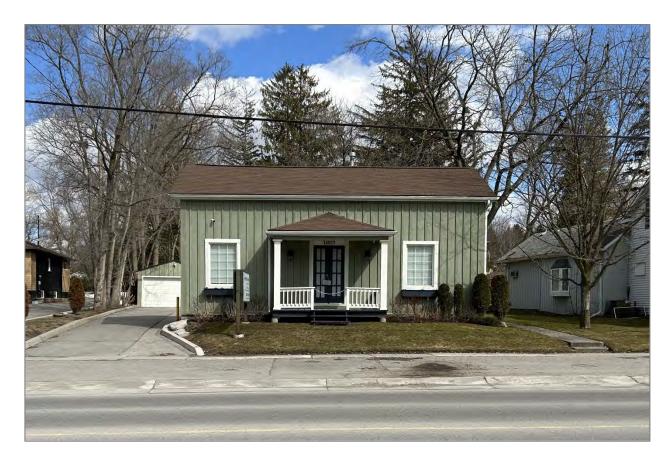
Property Name:	Richard Morris House / Ira Bellar House
Roll Number:	1954-000-221-282-00
Heritage Status:	Listed, Section 27 Part IV
Date:	1888
Architectural Style /	Vernacular; Classical Revival
Influence:	
Floorplan:	Rectangular
Storeys:	1.5
Foundation:	Unknown
Main Exterior Walls:	Siding – Wood Board and Batten
Roof:	Side gable with central chimney
Typical Window:	Rectangular, sash with white trim, 15-
	pane window
Main Entrance:	Flat, double leaf door each with eight
	narrow panes of glazing; centre hall
Main Stairs/Porch:	Wood 3 step porch. Partially enclosed
	porch across a portion of the front,
	southwest elevation with a hipped roof
	supported by square posts
Other Buildings:	N/A
Landscape Features:	Mature deciduous and coniferous trees
	line the northeast, southeast, and
	northwest property lines
Other Property	N/A
Features:

History Summary:	Residence of Richard Morris, a local harness maker and tinsmith, and later Ira Bellar, a local painter. A rear addition was added to the property by 1946. Aerial photographs and satellite images identify that no alterations to the property have been made on the property from 1927 to the present.  This is a commercial property that formerly served a residential purpose.
Thematic	N/A
Framework:	
Evaluation	This property meets criteria 7 of O. Reg. 9/06.
O. Reg. 9/06	It has contextual value because it supports the character of the district.

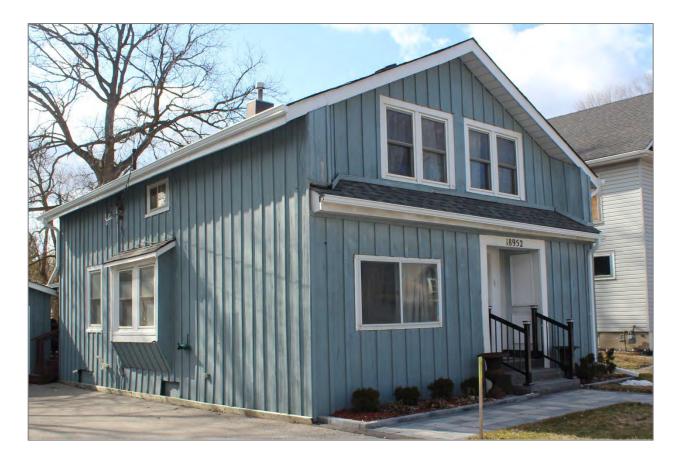
Г.
Property Name:	Thomas Watson House
Roll Number:	N/A
Heritage Status:	Listed, Section 27 Part IV
Date:	1913
Architectural Style /	Ontario Vernacular
Influence:	
Floorplan:	Rectangular with rear wing addition
Storeys:	1.5
Foundation:	Unknown
Main Exterior Walls:	Wood board and batten
Roof:	Front gable with overhanging eaves
Typical Window:	Rectangular, sash with simple wooden
	trim
Main Entrance:	Flat, solid single leaf door and plain
	wooden trim
Main Stairs/Porch:	Stone 3 step porch. Main door stepped
	back into the building, creating a
<u></u>	shallow porch
Other Buildings:	Shed to the main building's southwest
Landscape Features:	Mature deciduous trees along the
<u> </u>	southwest property line
Other Property	N/A
Features:

History	Residence of Thomas Watson. This was once the old warehouse attached to
Summary:	the abutting general store (at 18944 Leslie Street). The building was turned 180 degrees, detached from the store, and converted into a house. Xix Aerial photographs and satellite images identify that an addition was built on the rear of the building by 1978 and a larger shed was built by 1999.
	This is a residential property that formerly served a commercial purpose.
Thematic	N/A
Framework:	
Evaluation	This property meets two of the criteria from O. Reg. 9/06, including 7 and 8. It
O. Reg. 9/06	supports the character of the area and is historically linked to the adjacent property at 18944 Leslie Street.

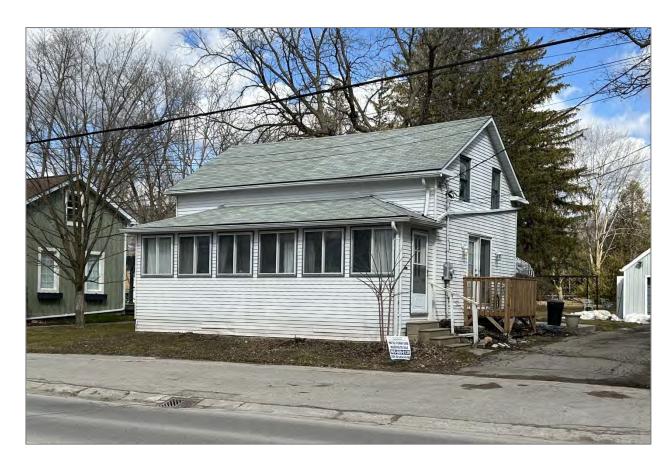
Property Name:	Richard Morris House
Roll Number:	1954-000-221-277-00
Heritage Status:	Listed, Section 27 Part IV
Date:	1870
Architectural Style /	Vernacular
Influence:	
Floorplan:	Rectangular with rear wing addition
Storeys:	1.5
Foundation:	Unknown
Main Exterior Walls:	Siding – Aluminium
Roof:	Front gable with return eaves
Typical Window:	Rectangular, casement with plain white
	trim
Main Entrance:	Flat, two leaf door both with central
	glazing; centre hall
Main Stairs/Porch:	Concrete 5 step enclosed porch along
	the entire southwest elevation. The
	porch has a hipped roof.
Other Buildings:	N/A
Landscape Features:	Mature deciduous and coniferous trees
	line the northeast, southeast, and
	northwest property lines
Other Property	N/A
Features:

History Summary:	Residence of Richard Morris. Morris was a harness maker and tinsmith. Aerial photographs and satellite images identify that a rear addition was added to the property by 1970 and by 1988 a second addition was added to the first addition.  This is a residential property.
Thematic	N/A
Framework:	
Evaluation	This property meets criteria 7 of O. Reg. 9/06. It supports the character of the
O. Reg. 9/06	district.

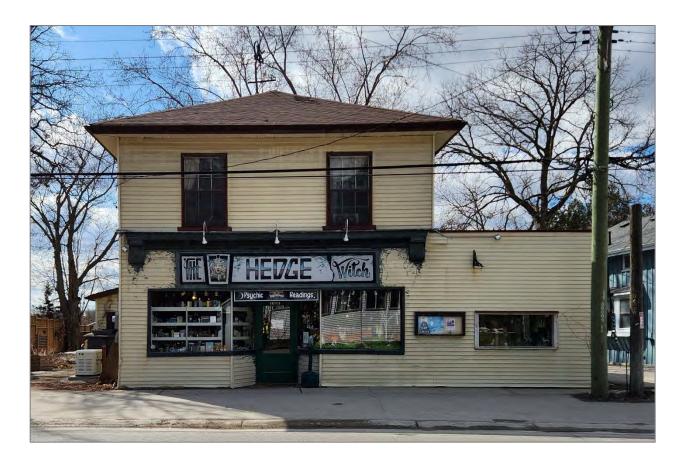
Property Name:	John C. Hogaboom General Store, David
	Willson Hughes General Store
Roll Number:	1954-000-220-438-00
Heritage Status:	Listed, Section 27 Part IV
Date:	c. 1878
Architectural Style /	Ontario Vernacular
Influence:	
Floorplan:	Rectangular with side addition
Storeys:	2
Foundation:	Unknown
<b>Main Exterior Walls:</b>	Aluminum siding
Roof:	Low hip
Typical Window:	Rectangular, sash, plain wood trim, lug
	sill with 6/6 window
Main Entrance:	Flat, single leaf door with central
	glazing
Main Stairs/Porch:	N/A
Other Buildings:	N/A
Landscape Features:	Mature deciduous trees line the
	southwest property line
Other Property	N/A
Features:

History Summary:	John C. Hogaboom General Store circa 1878. Hogaboom served as the Town clerk. ** Also known as the David Willson Hughes' General Store. The store was at ground level and living quarters were above. ** Aerial photographs and satellite images identify that a former shed in the property's southwest corner was removed by 1978 and replaced with a new shed by 1988.  This property has both a residential and commercial function.
Thematic Framework:	N/A
Evaluation	This property meets three criteria of <i>O. Reg. 9/06</i> including, criteria 4, 7 and
O. Reg. 9/06	8. It has historic value because of its connection to John Cl Hogaboom and for its use as a general store. It has contextual value because it supports the character of the area and has historical links to the adjacent property at 18952 Leslie Street.

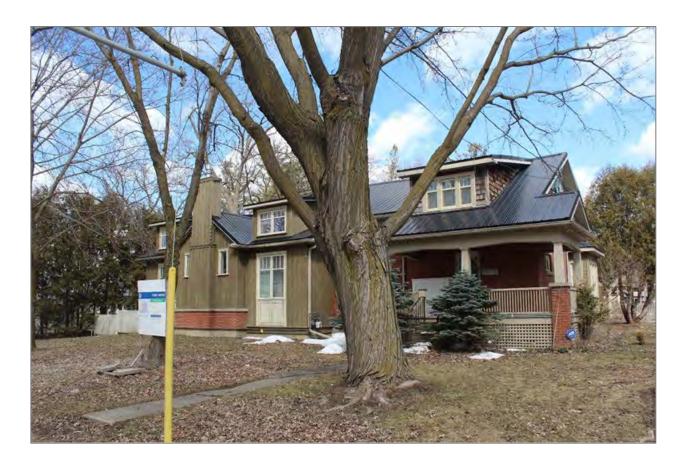
Property Name:	N/A
Roll Number:	N/A
Heritage Status:	N/A
Date:	Pre-1927
Architectural Style /	Vernacular, Arts and Crafts
Influence:	
Floorplan:	L-Shape with rear wing addition
	constructed between 2009 and 2011
Storeys:	2
Foundation:	Stone; Concrete
Main Exterior Walls:	Concrete – Red Brick; Siding -Wood
	Board and Batten
Roof:	Gable with shed dormers and chimney
Typical Window:	Rectangular, sash with beige trim and
	plain lug sills. A 3/1 window layout is
	common
Main Entrance:	Flat, single leaf door with simple trim
Main Stairs/Porch:	Wood 6 step porch. Partially enclosed
	porch across a portion of the primary,
	southwest elevation.
Other Buildings:	N/A
Landscape Features:	Mature deciduous and coniferous trees
	line each of the property lines
Other Property	N/A
Features:

History Summary:	Aerial photographs and satellite images show that the southmost, brick section of the building was constructed before 1927. Large, board and batten addition was added between 2009 and 2011.  This is a residential property.
Thematic	N/A
Framework:	
Evaluation	This property meets two criteria of <i>O. Reg. 9/06</i> . It meets criteria 1 for design
O. Reg. 9/06	value as a locally early example of an Arts and Crafts building in Sharon. It
	meets criteria 7 because it supports the character of the area.

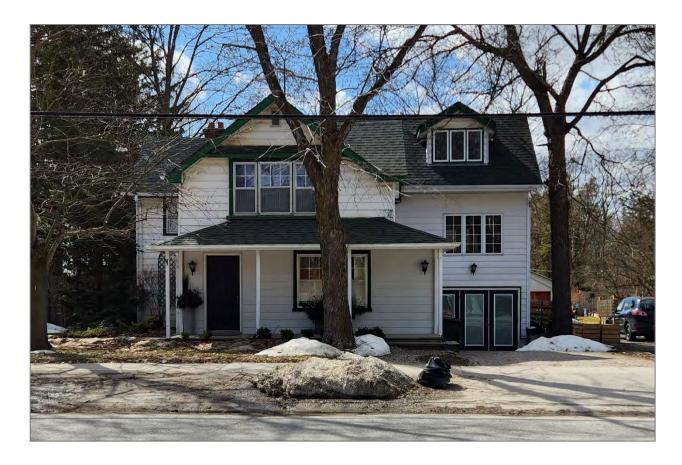
Property Name:	Rachel Hughes House, Maria Sterland
	House
Roll Number:	1954-000-220-436-00
Heritage Status:	Listed, Section 27 Part IV
Date:	c. 1856
Architectural Style /	Vernacular farmhouse
Influence:	
Floorplan:	L shape
Storeys:	1.5
Foundation:	Unknown
Main Exterior Walls:	Aluminum siding
Roof:	Cross gable with gable dormer
Typical Window:	Rectangular, sash with plain trim
Main Entrance:	Flat, solid single leaf door with plain
	trim
Main Stairs/Porch:	Wooden 2 step porch covered with a
	partial width hip roof supported by
	wooden posts
Other Buildings:	N/A
Landscape Features:	Mature deciduous and coniferous trees
	on all sides of the building
Other Property	Cobbled driveway and walkway
Features:

Residence of Rachel Hughes, wife of Israel Lundy and mother of Jacob, Judah,
and Reuben. Each of her sons participated in the 1837 rebellion.xxii The
residence was later owned by Maria Sterland, who was associated with the
Knight family.xxiii Aerial photographs and satellite images show that an
addition was added by 1988.
This is a residential property.
Political
This property meets two of the criteria of O. Reg. 9/06, including criteria 4
and 7. It is associated with local residents who took part in the 1837
Rebellion. It also supports the character of the district.

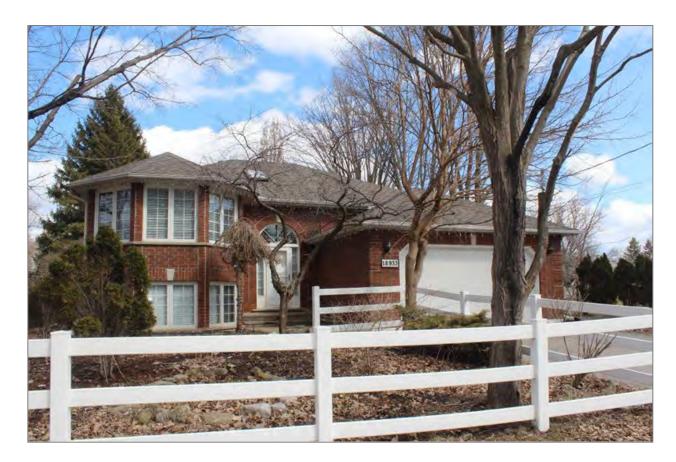
Property Name:	N/A
Roll Number:	N/A
Heritage Status:	N/A
Date:	1988-1999
Architectural Style /	Vernacular
Influence:	
Floorplan:	Rectangular
Storeys:	1.5
Foundation:	Concrete
Main Exterior Walls:	Concrete – Red Brick
Roof:	Hipped, hexagonal
Typical Window:	Rectangular, casement with white trim
	and concrete lug sill
Main Entrance:	Flat, solid single leaf door with semi-
	circular transom with voussoir and
	keystone and sidelights; centre hall
Main Stairs/Porch:	N/A
Other Buildings:	N/A
Landscape Features:	Mature coniferous and deciduous trees
<u></u>	line each property line
Other Property	White picket fence
Features:

History Summary:	Aerial photographs and satellite images show that two earlier buildings occupied this property before the current residence. The first was an L shaped building constructed prior to 1927. The second was a rectangular building constructed by 1970.  This is a residential property.	
Thematic Framework:	N/A	
Evaluation O. Reg. 9/06	This property does not meet any of the criteria of O. Reg. 9/06.

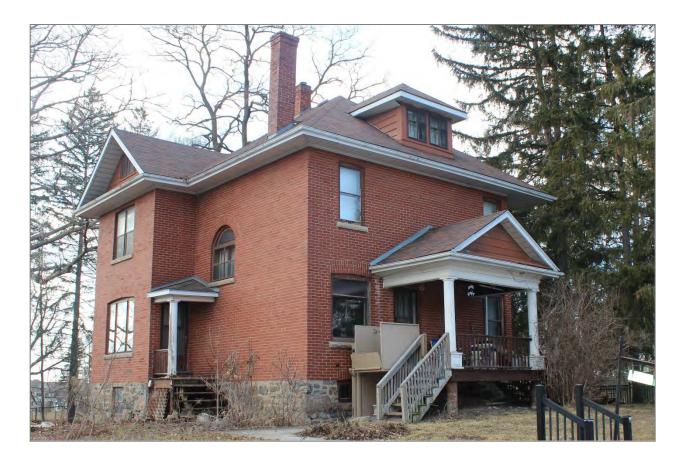
Property Name:	Michael Ramsay House
Roll Number:	1954-000-021-525-00
Heritage Status:	Listed, Section 27 Part IV
Date:	c. 1915
Architectural Style /	Edwardian Classical
Influence:	
Floorplan:	Rectangular
Storeys:	2.5
Foundation:	Stone
Main Exterior Walls:	Red brick
Roof:	Medium hip, pedimented gable
Typical Window:	Segmentally arched, sash with brick
	voussoir and concrete lug sill and 1/1
	windows
Main Entrance:	Segmentally arched with brick voussoir.
	Single leaf door with central glazing
Main Stairs/Porch:	Wooden 6 step porch covered with a
	pedimented gable roof supported by
	Doric columns
Other Buildings:	N/A
Landscape Features:	Building surrounded by mature
	deciduous and coniferous trees to the
	northwest, southeast, and southwest
Other Property	N/A
Features:

History Summary:	Residence of Michael Ramsay, a local farmer. XXIV Ramsay purchased the property containing the Sharon Temple in 1912 and demolished the meeting house to build this house. Materials for the house came from John D. Willson House and Children of Peace 2nd Meeting House. XXV Aerial photographs and satellite images identify that no major changes have occurred to the property from 1927 to the present.
	The meeting house that was on this property was used as a school.  This is a residential property.
Thematic Framework:	Social Development
Evaluation O. Reg. 9/06	This property meets three criteria of <i>O. Reg. 9/06</i> , including 1, 4, and 7. It has Design value as a locally representative example of the Edwardian Classical architectural style. It has historical value because it is associated with Michael Ramsay and was the site of the Children of Peace meeting house. It has contextual value because it supports the character of the area.

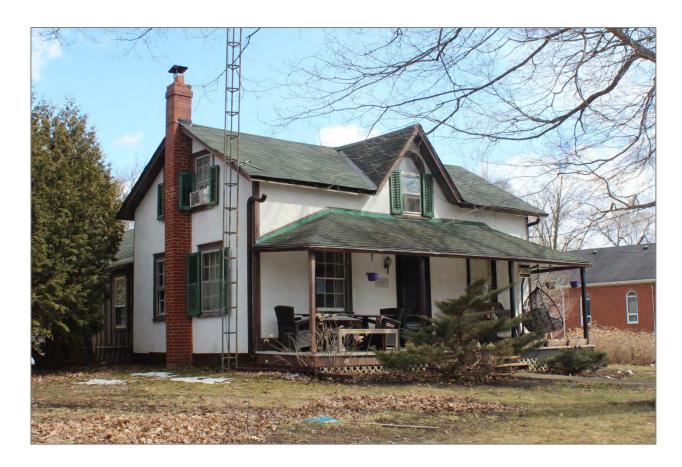
Property Name:	Amos Lundy Farmhouse
Roll Number:	1954-000-221-205-00
Heritage Status:	Listed, Section 27 Part IV
Date:	1850
Architectural Style /	Ontario Cottage; Gothic Revival
Influence:	
Floorplan:	T-Shape with rear wing addition
Storeys:	1.5
Foundation:	Unknown
Main Exterior Walls:	Stucco
Roof:	Centre gable with red brick chimney
Typical Window:	Rectangular, sash with green trim,
	storm shutters, and 6/6 windows
Main Entrance:	Flat, solid single leaf door with simple
	trim; centre hall
Main Stairs/Porch:	Wood 3 step porch across the entire
	primary, southwest elevation of the
	building. The porch has a hipped roof
	supported by square posts
Other Buildings:	Shed to the southeast of the main
	building
Landscape Features:	Mature deciduous and coniferous trees
	line all property lines and are
	interspersed throughout the property
Other Property	N/A
Features:

History	In 1860 Elijah Mack was the owner of the land. By 1860 it was owned by J.
Summary:	Lundy. By 1878 it was owned by Amos Lundy. Lundy was a member of the
	Children of Peace. Aerial photographs and satellite images identify that the rear addition and the removal of several large buildings to the current building's east occurred by 1954.
	This is a residential property.
Thematic	N/A
Framework:	
Evaluation	This property meets three of the criteria of O. Reg. 9/06, including 1, 4 and 7.
O. Reg. 9/06	It has physical value as a relatively rare and representative local example of a
	modest, gothic revival inspired Ontario Cottage style building. It has historical
	value because of its association with Amos Lundy. It has contextual value
	because it supports the character of the district.
