# **Sharon Heritage Conservation District Study**

**Volume III**

# **Individual Property Inventory and Evaluation**

East Gwillimbury, Ontario

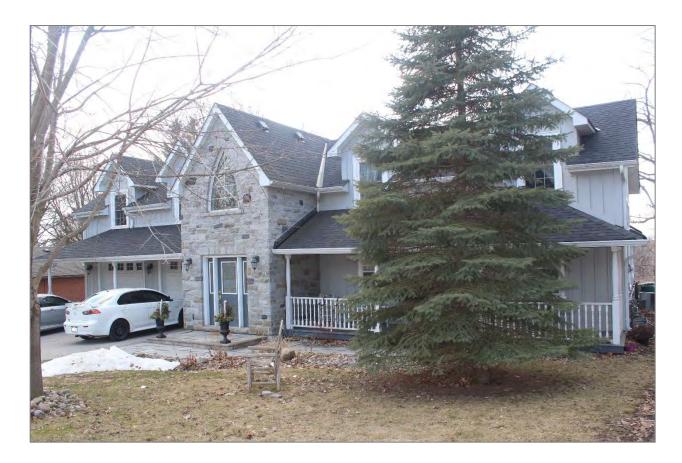
Property Name:	Phoebe Willson House, John Tate House
Roll Number:	1954-000-220-378-00
Heritage Status:	Listed, Section 27 Part IV
Date:	c. 1880
Architectural Style /	Vernacular
Influence:	
Floorplan:	Rectangular with rear wing addition
Storeys:	2
Foundation:	Unknown
Main Exterior Walls:	Stone veneer, wood board and batten
Roof:	Cross gable with broken eave dormers
	with projecting gable roofs
Typical Window:	Rectangular, sash, 12-pane windows
	with decorative wood frame
Main Entrance:	Flat, stone veneer voussoir, side lights
Main Stairs/Porch:	Stone one step porch
Other Buildings:	N/A
Landscape Features:	Mature coniferous and deciduous trees
	on all sides of the building
Other Property	N/A
Features:

History Summary:	Residence of Phoebe H. Willson, Hugh D. Willson's wife (son of David Willson), and later John Tate. John Tate was a blacksmith. The original section of the house forms part of north end of present house.xxvi Aerial photographs and satellite images identify that an addition was added to the rear of the building prior to 1927. A second addition was added by 2005.  This is a residential property.
Thematic Framework:	N/A
Evaluation O. Reg. 9/06	This property meets two of the criteria of <i>O. Reg. 9/06</i> , including criteria 4 and 7. It has associative value for its connection to Phoebe H. Willson, a Children of Peace member, and John Tate. It has contextual value because it supports the character of the district.

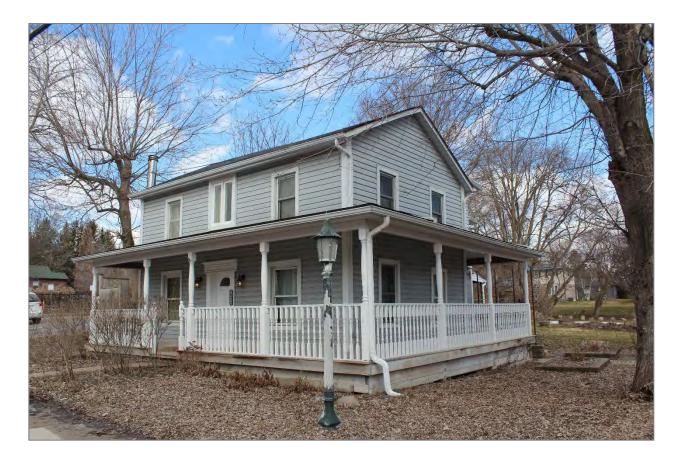
Property Name:	Robert Brammer House / John Wreggit
	House / Fred McKrill House
Roll Number:	1954-000-221-198-00
Heritage Status:	Listed, Section 27 Part IV
Date:	1860
Architectural Style /	Vernacular; Classical Revival
Influence:	
Floorplan:	Rectangular
Storeys:	2
Foundation:	Unknown
<b>Main Exterior Walls:</b>	Siding – Vinyl
Roof:	Side gable
Typical Window:	Rectangular, sash with white trim, 1/1
	windows
Main Entrance:	Flat, single leaf front door with semi-
	circular glazing and decorative trim
Main Stairs/Porch:	On step porch that wraps around the
	southwest and southeast elevation. A
	shed roof supported by decorative
	wood posts covers the porch
Other Buildings:	N/A
Landscape Features:	Mature deciduous and coniferous trees
	line each property line
Other Property	N/A
Features:

History Summary:	Residence of Robert Brammer, a blacksmith; John Wreggit, a local farmer; and Fred McKrill, a labourer and railway worker.xxvii
	The building may have been the first school under the Children of Peace called the Female Institution in the Village of Hope.
	Architect John T. Stokes designed the building. **xviii Aerial photographs and satellite images identify that a large garage was built on the property by 1988.
	This is a residential property.
Thematic Framework:	N/A
Evaluation O. Reg. 9/06	This property meets two criteria of <i>O. Reg. 9/06</i> , including criteria 4 and 7. It has historical value for its connection to Rober Brammer. It has contextual value because it contributes to the character of the district.

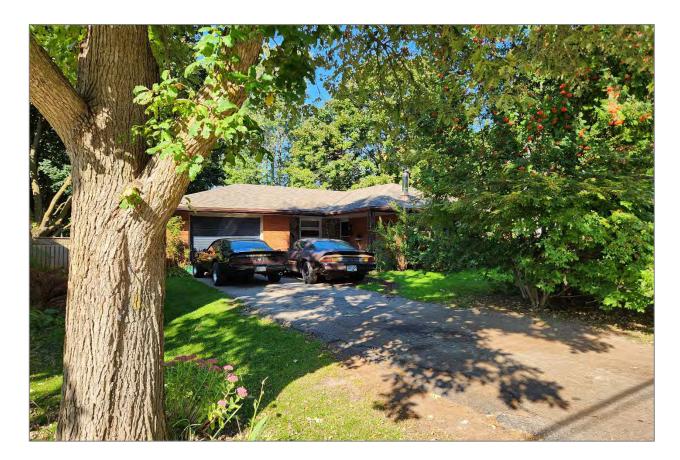
Property Name: N/A  Roll Number: N/A	
- · · · · · · · · · · · · · · · · · · ·	
Heritage Status: N/A	
<b>Date:</b> 1960-1969	
Architectural Style / Mid-20 <sup>th</sup> Century Bungalow	
Influence:	
Floorplan: T shape	
Storeys: 1	
Foundation: Concrete	
Main Exterior Walls: Red brick	
Roof: Low hip	
Typical Window: Rectangular, sash with concrete	sill
Main Entrance: Single leaf door	
Main Stairs/Porch: N/A	
Other Buildings: N/A	
Landscape Features: Mature coniferous and deciduo	us trees
on all sides of the building	
Other Property N/A	
Features:

History	This property is on Lot 10 Concession 2. David Willson owned the property
Summary:	between 1857 and 1878. This property appears to have been used as a field. Aerial photographs and satellite images do not show any buildings or structures on the property until 1970.
	This is a residential property.
Thematic	N/A
Framework:	
Evaluation	This property does not meet any of the criteria of O. Reg. 9/06.
O. Reg. 9/06

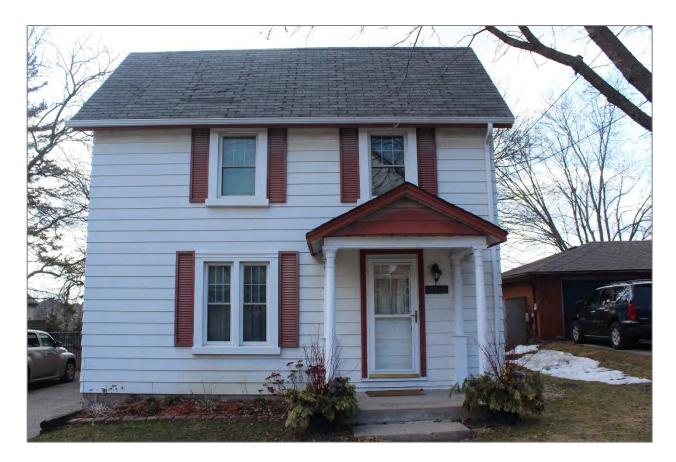
<b>Property Name:</b>	John Wesley House
Roll Number:	1954-000-220-374-00
Heritage Status:	Listed, Section 27 Part IV
Date:	c. 1885
Architectural Style /	Ontario Vernacular, Classical Revival
Influence:	
Floorplan:	L shape with rear wing addition
Storeys:	1.5
Foundation:	Unknown
Main Exterior Walls:	Aluminum siding
Roof:	Side gable with overhanging eave
Typical Window:	Rectangular, sash, 6/1 window with
	plain wood trim, wood lug sill, and
	decorative storm shutters
Main Entrance:	Flat, single leaf door with central
	glazing
Main Stairs/Porch:	Concrete 2 step porch covered by a
	gable roof supported by Doric columns
Other Buildings:	N/A
Landscape Features:	Mature coniferous trees line the
	southeast, southwest, and northwest
	property line
Other Property	N/A
Features:

History	Residence of John Wesley, a local farmer and labourer.xxix
Summary:	The property (but not this building) may have been the site of the first Girls'
	School in Sharon 1820-1843.xxx
	Aerial photographs and satellite images identify no major alterations have
	occurred on the property since 1927.
	This is a residential property.
Thematic	N/A
Framework:	
Evaluation	This property meets one criteria –criteria 7—of O. Reg. 9/06. It supports the
O. Reg. 9/06	character of the district.

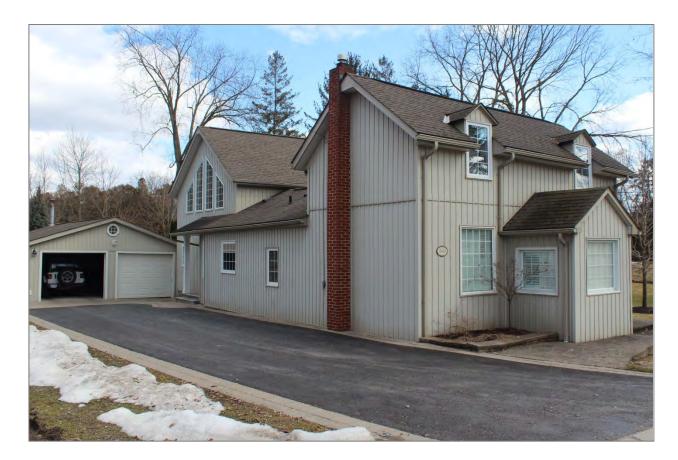
Property Name:	Dr. John Wilmot Montgomery House
Roll Number:	1954-000-221-195-00
Heritage Status:	Listed, Section 27 Part IV
Date:	1872
Architectural Style /	Vernacular; Classical Revival
Influence:	
Floorplan:	L-Shape with rear wing addition
Storeys:	1.5
Foundation:	Unknown
Main Exterior Walls:	Siding – Wood Board and Batten
Roof:	Side gable with gable dormers and red
	brick chimney
Typical Window:	Rectangular, casement with plain white
	trim
Main Entrance:	Flat, solid single leaf door with plain
	trim; centre hall
Main Stairs/Porch:	NA
Other Buildings:	Garage to the northeast of the main
	building
Landscape Features:	Mature deciduous and coniferous trees
	line the northeast elevation and part of
	the southeast, southwest, and
	northwest elevation
Other Property	Driveway
Features:

History	Dr. John Wilmot Montgomery was a local physician before moving to	
Summary:	Kingston to become the assistant medical superintendent of the Kingston	
	Asylum. Montgomery's daughter, O.B. Shepard helped save the Sharon	
	Temple from demolition in 1917.xxxi Aerial photographs and satellite images	
	identify that two additions have been added to the rear of the building, the	
	first by 1954 and the second by 2005. A garage was built by 1970.	
	This is a residential property.	
Thematic	N/A	
Framework:		
Evaluation	This property meets two criteria of <i>O. Reg. 9/06</i> , including criteria 4 and 7. It	
O. Reg. 9/06	has historical value because it is associated with Dr. John Wilmot	
	Montgomery. The property has contextual value because it supports the	
	character of the district.

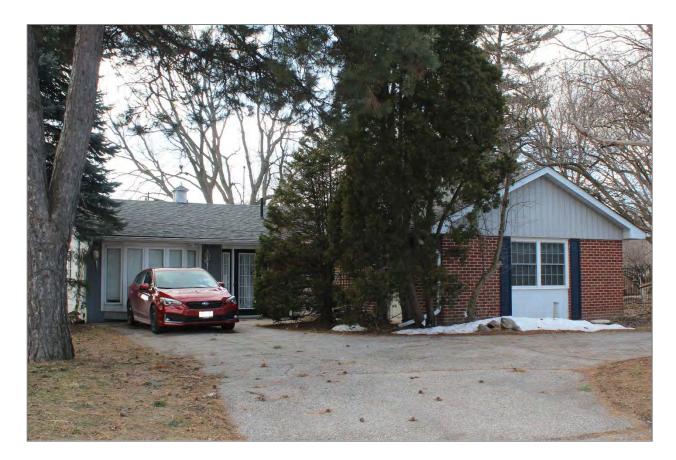
Property Name:	N/A
Roll Number:	N/A
Heritage Status:	N/A
Date:	1960
Architectural Style /	Mid-20 <sup>th</sup> Century Bungalow
Influence:	
Floorplan:	L shape with rear wing addition
Storeys:	1
Foundation:	Concrete
Main Exterior Walls:	Stucco, red brick
Roof:	Gable, front and side
Typical Window:	Rectangular, sash, 6/6 windows with
	plain trim
Main Entrance:	Flat, single leaf door with central
	glazing and sidelights
Main Stairs/Porch:	N/A
Other Buildings:	Shed to the building's southwest
Landscape Features:	Mature coniferous and deciduous trees
	on all sides of the building
Other Property	N/A
Features:

History Summary:	This property is on Lot 10 Concession 2. David Willson owned the property between 1857 and 1878. This property appears to have been used as a field. Aerial photographs and satellite images do not show any buildings or structures on the property until 1970.  This is a residential property.
Thematic	N/A
Framework:	
Evaluation	This property does not meet any of the criteria from O. Reg. 9/06.
O. Reg. 9/06

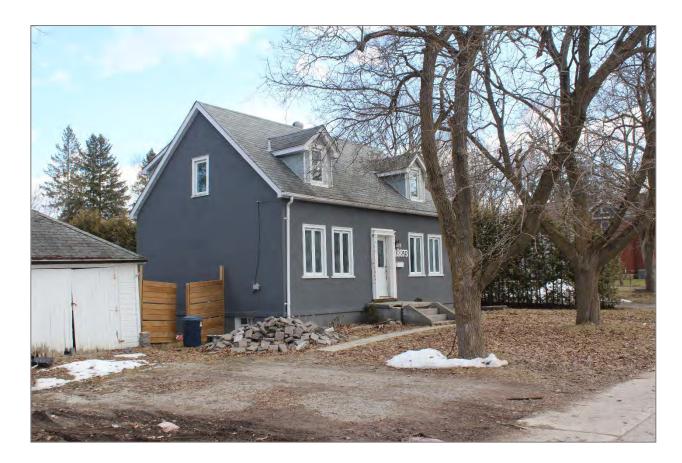
Property Name:	N/A
Roll Number:	N/A
Heritage Status:	N/A
Date:	1946-1953
Architectural Style /	Vernacular
Influence:	
Floorplan:	Rectangular
Storeys:	1.5
Foundation:	Stone
Main Exterior Walls:	Stucco
Roof:	Gable with gable dormers on the
	southwest elevation and a shed dormer
	on the northeast elevation
Typical Window:	Rectangular, casement with white trim
	and plain lug sill
Main Entrance:	Flat, single leaf door with central
	glazing and decorative trim; centre hall
Main Stairs/Porch:	N/A
Other Buildings:	Shed to the north of the main building
Landscape Features:	Mature deciduous and coniferous trees
	line portions of all property lines
Other Property	N/A
Features:

History Summary:	This property is on Lot 10 Concession 3. In 1860 Elijah Mack was the owner of the land. By 1860 J. Lundy owned it. By 1878 Amos Lundy owned it. This property appears to have been used as a field. Aerial photographs and satellite images do not show any buildings or structures on the property until 1954.  This is a residential property.
Thematic	N/A
Framework:	
Evaluation	This property meets criteria 7 of O. Reg. 9/06, it supports the character of the
O. Reg. 9/06	district.

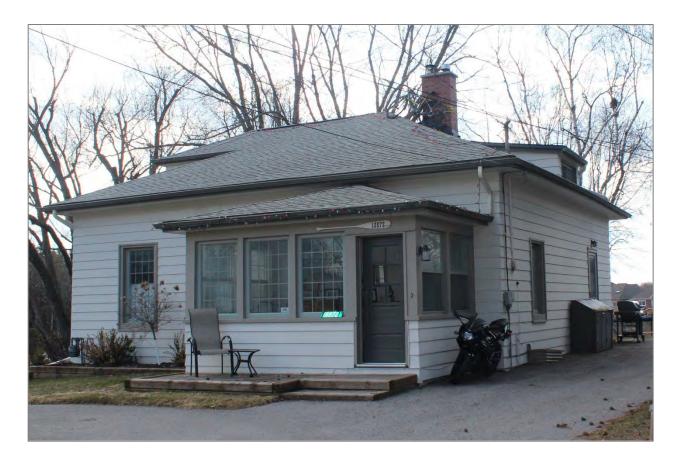
Property Name:	Hugh D. Willson House, Crimin Cottage
Roll Number:	1954-000-220-369-00
Heritage Status:	Listed, Section 27 Part IV
Date:	c. 1870
Architectural Style /	Vernacular cottage
Influence:	
Floorplan:	Square
Storeys:	1.5
Foundation:	Unknown
Main Exterior Walls:	Wood clapboard siding
Roof:	Low hip
Typical Window:	Rectangular, sash, 24-pane window
	with decorative wood trim
Main Entrance:	Flat, single leaf door with central
	glazing and plain trim
Main Stairs/Porch:	Concrete 2 step porch
Other Buildings:	N/A
Landscape Features:	Mature deciduous and coniferous trees
	along the southeast, southwest, and
	northwest property lines. Small garden
	adjacent to the property's driveway
Other Property	N/A
Features:

History Summary:	Residence of Hugh D. Willson, the son of David and Phoebe Willson. Willson was a member of the Children of Peace and took part in the 1837 rebellion. XXXIII Aerial photographs and satellite images identify that no major alterations have occurred on the property since 1927.  This is a residential property.
Thematic Framework:	N/A
Evaluation O. Reg. 9/06	This property meets two criteria from <i>O. Reg. 9/06</i> , including criteria 4 and 7. It has associative value because it is associated with Hugh. D. Willson and the Children of Peace. It has contextual value because it supports the character of the district.

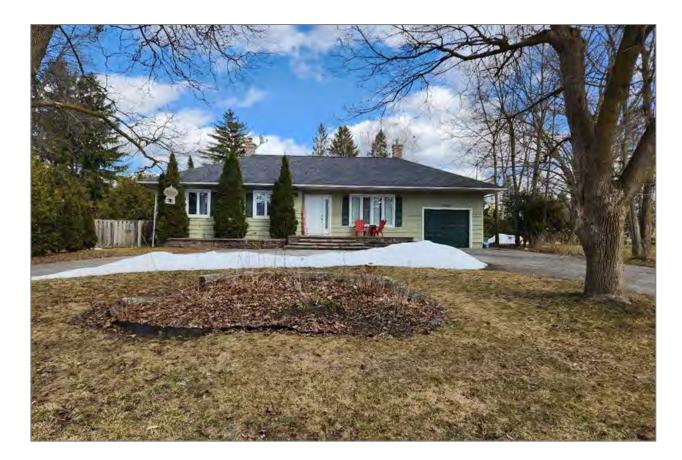
Property Name:	N/A
Roll Number:	N/A
Heritage Status:	N/A
Date:	1954
Architectural Style /	Vernacular, Ranch
Influence:	
Floorplan:	Rectangular
Storeys:	1
Foundation:	Concrete
<b>Main Exterior Walls:</b>	Siding – Vinyl
Roof:	Hipped with two chimneys
Typical Window:	Rectangular, casement with white trim
	and decorative storm shutters.
Main Entrance:	Flat, solid single leaf door with sidelight
	on the south edge of the door; center
	hall
Main Stairs/Porch:	N/A
Other Buildings:	Shed to the east of the main building
Landscape Features:	Mature deciduous and coniferous trees
	line each property line
Other Property	Long driveway

History Summary:	This property is on Lot 9 Concession 3. In 1857 Humphry Finch was the owner of the land. By 1860 John Doan owned it. By 1878 Jesse Doan owned it. This property appears to have been used as a field. Aerial photographs and satellite images do not show any buildings or structures on the property until 1954.
	This is a residential property.
Thematic	N/A
Framework:	
Evaluation	This property does not meet any criteria of O. Reg. 9/06.
O. Reg. 9/06

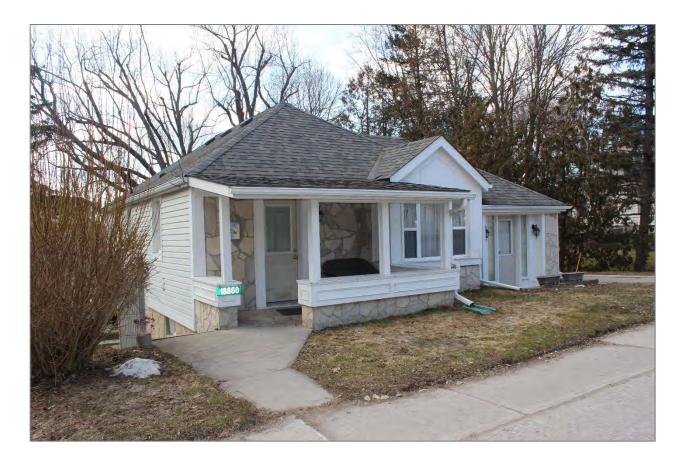
Property Name:	N/A
Roll Number:	N/A
Heritage Status:	N/A
Date:	1946-1953
Architectural Style /	Vernacular, Minimal Traditional
Influence:	
Floorplan:	L shape
Storeys:	1
Foundation:	Unknown
<b>Main Exterior Walls:</b>	Stone veneer, vinyl siding
Roof:	Medium hip
Typical Window:	Rectangular, sash with plain trim
Main Entrance:	Flat, single leaf door with central
	glazing and plain trim
Main Stairs/Porch:	At-grade porch, shed roof supported by
	a short stone veneer and square posts
Other Buildings:	Shed to the building's northwest
Landscape Features:	Mature deciduous and coniferous trees
	along the northwest and southwest
	property lines
Other Property	N/A
Features:

History Summary:	This property is on Lot 10 Concession 2. David Willson owned the property between 1857 and 1878. This property appears to have been used as a field. Aerial photographs and satellite images do not show any buildings or structures on the property until 1954.  This is a residential property.
Thematic Framework:	N/A
Evaluation O. Reg. 9/06	This property meets criteria 7 of <i>O. Reg. 9/06</i> , it supports the character of the district.

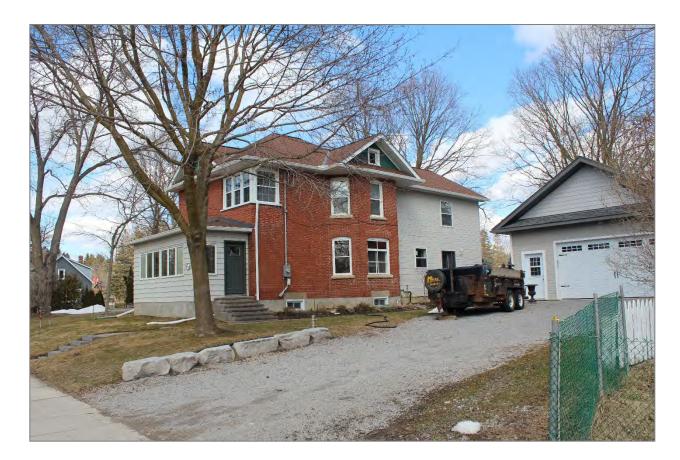
Property Name:	Albert Cockeril House
Roll Number:	1954-000-221-188-00
Heritage Status:	Listed, Section 27 Part IV
Date:	1912
Architectural Style /	Vernacular, Edwardian
Influence:	
Floorplan:	Rectangular with rear wing addition
Storeys:	2.5
Foundation:	Unknown
Main Exterior Walls:	Brick (main house) and aluminum siding
	(front porch)
Roof:	Complex
Typical Window:	Rectangular or segmentally arched,
	sash with white trim and concrete lug
	sill with either 1/1 or 6/6 windows
Main Entrance:	Flat, single leaf door with central
	glazing; centre hall
Main Stairs/Porch:	Stone 7 stair, enclosed front porch
	across the southwest elevation
Other Buildings:	Garage with gable roof to the south of
	the main building
Landscape Features:	Mature deciduous and coniferous trees
	line the northeast and southeast
	property lines and are intermittently
	placed within the property
Other Property	Driveway
Features:

History Summary:	Residence of Albert Cockeril, a field labourer and motorman. The building materials came from the Mansion House, a hotel that closed in 1910. Aerial photographs and satellite images identify that the rear addition was built between 1946 and 1954 and the large garage was built by 2021.  This is a residential property.
Thematic	N/A
Framework:	
Evaluation	This property meets criteria 7 of O. Reg. 9/06, it supports the character of the
O. Reg. 9/06	district.

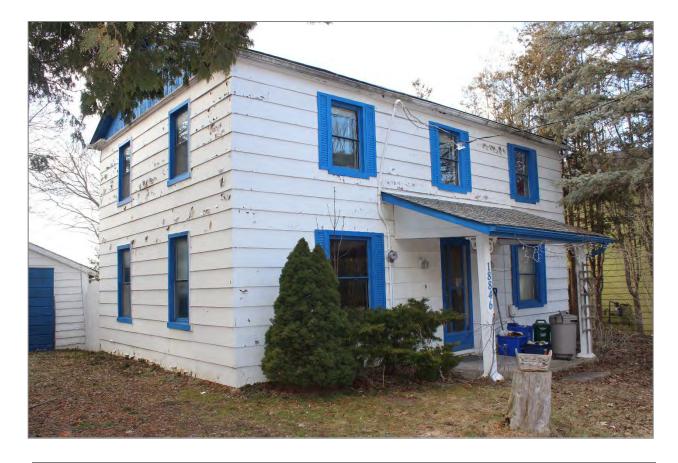
Property Name:	James Kavanagh House, William
	Theakston Shop
Roll Number:	1954-000-220-363-00
Heritage Status:	Listed, Section 27 Part IV
Date:	c. 1880
Architectural Style /	Ontario Vernacular
Influence:	
Floorplan:	Rectangular with rear wing addition
Storeys:	2
Foundation:	Unknown
Main Exterior Walls:	Vinyl clapboard siding
Roof:	Side gable with return eave
Typical Window:	Rectangular, sash, 1/1 window with
	plain trim and decorative storm
	shutters
Main Entrance:	Flat, single leaf door with central
	glazing and plain trim
Main Stairs/Porch:	One concrete riser porch covered by a
	shed roof supported by square posts
Other Buildings:	Small shed to the building's southwest
Landscape Features:	Mature coniferous and deciduous trees
	along the northwest and southwest
	property line
Other Property	N/A
Features:

Residence and shop of James Kavanagh who was a member of the Children of Peace. Kavanagh operated the telegraph here and was the vice president of the Metropolitan Life Insurance Company. James Kavanagh took part in the 1837 Rebellion and was wounded, eventually dying from the injury.xxxv

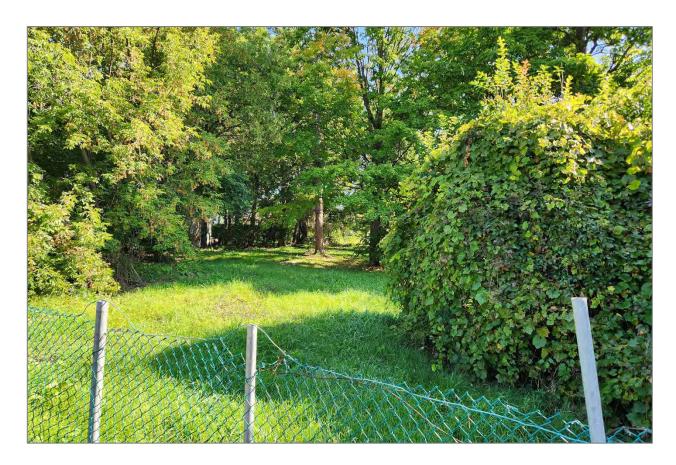
T
Property Name:	N/A
Roll Number:	N/A
Heritage Status:	N/A
Date:	N/A
Architectural Style /	N/A
Influence:	
Floorplan:	N/A
Storeys:	N/A
Foundation:	N/A
Main Exterior Walls:	N/A
Roof:	N/A
Typical Window:	N/A
Main Entrance:	N/A
Main Stairs/Porch:	N/A
Other Buildings:	N/A
Landscape Features:	Mature deciduous trees interspersed
	throughout the property
Other Property	Vacant lot
Features:

Aerial photographs and satellite images show a building was on the northwest corner of this lot until 1999. The former building abutted Leslie
northwest corner of this lot until 1999. The former building abutted Leslie
Street and had a similar setback to the neighbouring buildings on 18817 and 18849 Leslie Street. The property has remained vacant.
This was a residential property.
N/A
This property does not meet any of the criteria from O. Reg. 9/06.

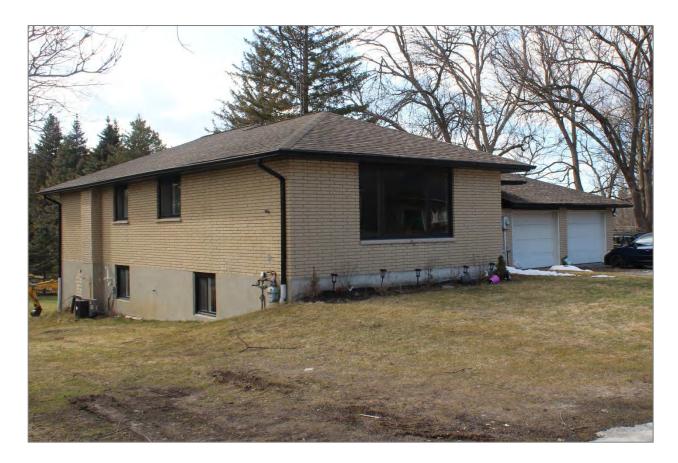
Property Name:	N/A
Roll Number:	N/A
Heritage Status:	N/A
Date:	1970
Architectural Style /	Bungalow
Influence:	
Floorplan:	T shape
Storeys:	1
Foundation:	Concrete
Main Exterior Walls:	Buff brick
Roof:	Low hip
Typical Window:	Rectangular, sash window with plain
	concrete slip sill
Main Entrance:	Flat, solid single leaf door
Main Stairs/Porch:	Concrete 3 step porch
Other Buildings:	Small shed the building's southwest
Landscape Features:	Mature coniferous and deciduous
	intermittently placed within the
	property and along the southeast,
	southwest, and northwest property
	lines
Other Property	N/A
Features:

History	This property is on Lot 9 Concession 2. In 1857 T. Hughes was the owner of	
Summary:	the land. By 1860 P. Rowan owned it. By 1878 G.M. Doan owned it. This	
	property appears to have been used as a field. Aerial photographs and	
satellite images identify that no major alterations have been made to the		
property since its construction.		
	This is a residential property.	
Thematic	N/A	
Framework:		
Evaluation	This property does not meet any of the criteria from O. Reg. 9/06.	
O. Reg. 9/06

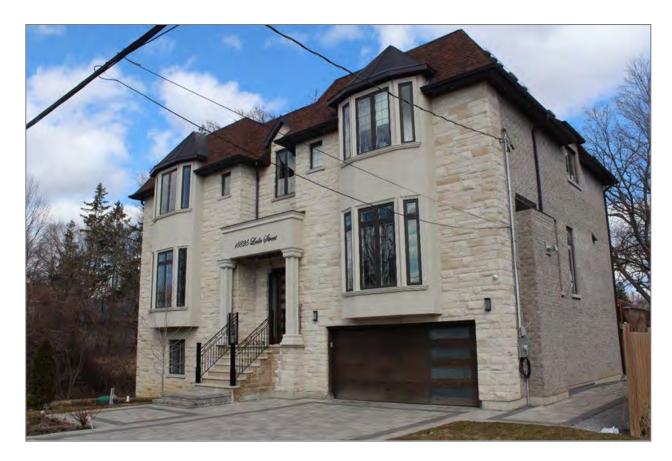
-
Property Name:	N/A
Roll Number:	N/A
Heritage Status:	N/A
Date:	2018
Architectural Style /	Vernacular, Modern Chateau
Influence:	
Floorplan:	Square
Storeys:	2
Foundation:	Concrete
Main Exterior Walls:	Stone veneer
Roof:	Mansard
Typical Window:	Rectangular, casement with beige trim
	and concrete lug sill
Main Entrance:	Flat, single leaf door with seven
	rectangular glazed panels and
	sidelights; centre hall
Main Stairs/Porch:	Stone veneer, nine step entry
Other Buildings:	N/A
Landscape Features:	Mature deciduous and coniferous trees
	line the northeast, southeast, and
	northwest property lines; small garden
	to the southwest of the building
Other Property	N/A
Features:

History Summary:  Aerial photographs and satellite images show a building construct 1927 was centrally located along the west property line until 2018 former building was demolished in 2018 and the present building subsequently developed.  This is a residential property.	
Thematic	N/A
Framework:	
Evaluation	This property does not meet any of the criteria from O. Reg. 9/06.
O. Reg. 9/06

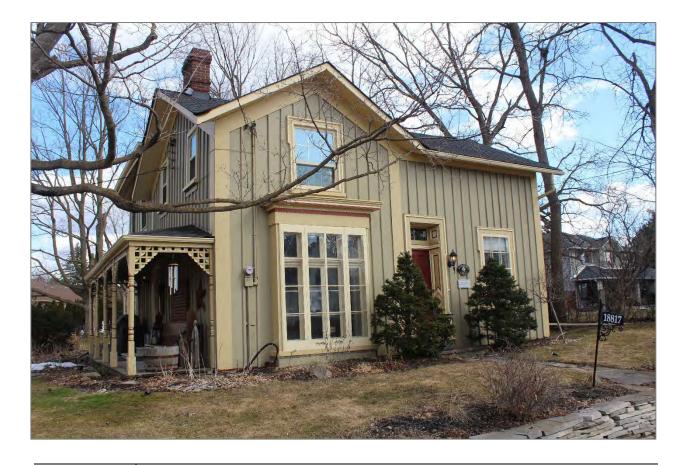
Property Name:	John T. Stokes House / Maplebyrn
Roll Number:	1954-000-221-181-00
Heritage Status:	Listed, Section 27 Part IV
Date:	1852
Architectural Style /	Vernacular
Influence:	
Floorplan:	Square
Storeys:	1.5
Foundation:	Unknown
Main Exterior Walls:	Siding – Wood Board and Batten
Roof:	Gable with red brick chimney
Typical Window:	Rectangular, sash with beige trim and
	sills
Main Entrance:	Flat, solid single leaf door with transom
	and decorative wood trim; centre hall
Main Stairs/Porch:	Porch along the northwest elevation
	with hipped roof supported by
	decorative wood posts
Other Buildings:	Two small sheds are on the property,
	one to the north of the residence and
	one to the northeast.
Landscape Features:	Mature deciduous and coniferous trees
	line the southeast property line and
	parts of the northeast and southwest
	property lines
Other Property	Driveway and stone walkway
Features:

Built by architect John T. Stokes in 1852. In addition to being an architect, Stokes served as Clerk-Treasurer for East Gwillimbury between 1856 and 1887. The building was built around a smaller house formerly occupying the property. The board and batten shed to the residence's north was a post office. XXXVIIII Aerial photographs and satellite images identify that few changes have occurred to the property since 1927.

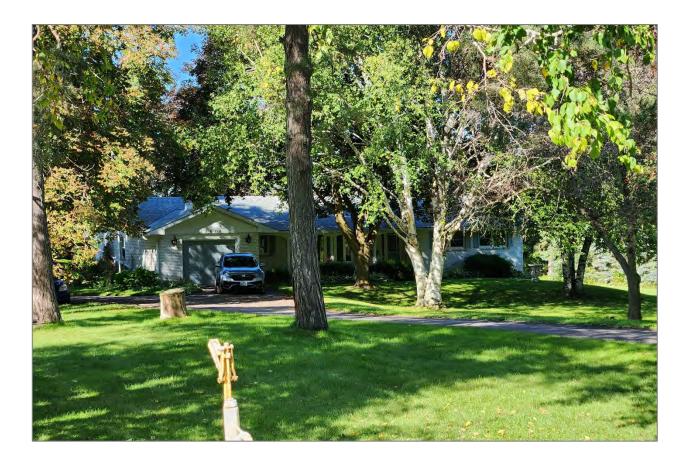
T
Property Name:	N/A
Roll Number:	N/A
Heritage Status:	N/A
Date:	1970-1978
Architectural Style /	20 <sup>th</sup> Century Bungalow
Influence:	
Floorplan:	Rectangular
Storeys:	1
Foundation:	Unknown
Main Exterior Walls:	Light brick
Roof:	Side gable
Typical Window:	Unknown
Main Entrance:	Unknown
Main Stairs/Porch:	Unknown
Other Buildings:	Large shed to the southwest of the
	building
Landscape Features:	Mature coniferous and deciduous trees
	intermittently spread throughout the
	property, located along
Other Property	N/A
Features:

History	This property is on Lot 9 Concession 2. In 1857 T. Hughes was the owner of	
Summary:	the land. By 1860 P. Rowan owned it. By 1878 G.M. Doan owned it. This	
	property appears to have been used as a field. Aerial photographs and	
	satellite images identify that no major alterations have been made to the	
	property since its construction.	
	This is a residential property.	
Thematic	N/A	
Framework:		
Evaluation	This property does not meet any of the criteria of O. Reg. 9/06.	
O. Reg. 9/06	This property has a more rural character than many others in the Study Area.

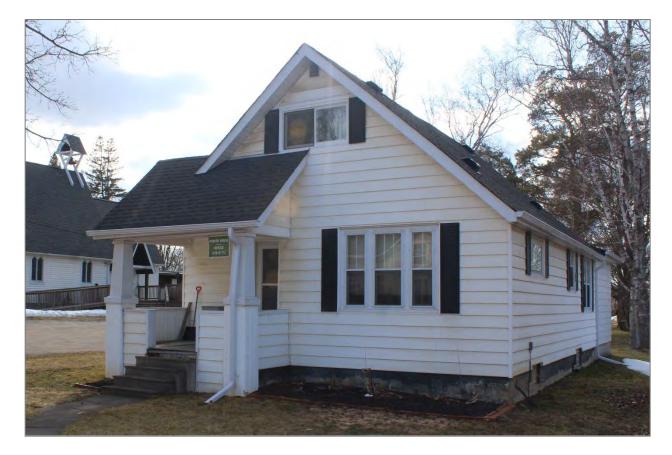
Property Name:	St. James the Apostle Anglican Church
	Parish House, Woodlawn
Roll Number:	N/A
Heritage Status:	N/A
Date:	Pre-1927
Architectural Style /	Vernacular, Minimal Traditional
Influence:	
Floorplan:	Rectangular with rear wing addition
Storeys:	1.5
Foundation:	Unknown
Main Exterior Walls:	Vinyl clapboard siding
Roof:	Front gable with shed roof dormer
Typical Window:	Rectangular, sash windows with plain
	trim and decorative storm shutters
Main Entrance:	Flat, single leaf door with central
	glazing and simple trim
Main Stairs/Porch:	Concrete 5 riser enclosed porch with
	steep shed roof supported by tapered
	square posts on square piers
Other Buildings:	N/A
Landscape Features:	Mature deciduous and coniferous trees
	to the southeast, southwest, and
	northwest of the building
Other Property	N/A
Features:

History Summary:	Parish house for St. James the Apostle Anglican Church. Aerial photographs and satellite images identify that an addition was constructed by 1978. A shed was formerly located to the southwest of the main building but was demolished prior to 1999.  This is an institutional property.
Thematic	Religious, Social Development
Framework:	Religious, social bevelopment
Evaluation O. Reg. 9/06	This property meets three criteria from <i>O. Reg. 9/06</i> , including 4, 7 and 8. It has associative value because, as the parish house to the Anglican church it is associated with the local Anglican community. It has contextual value because it supports the character of the area and has visual and functional links to the church next door.

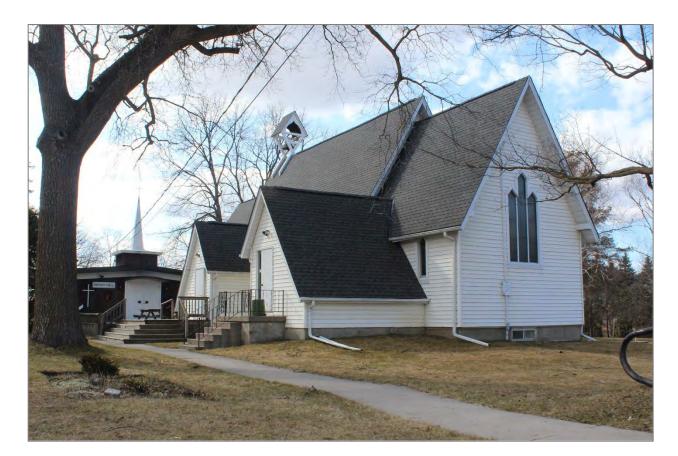
Property Name:	St. James the Apostle Anglican Church
Roll Number:	1954-000-220-352-00
Heritage Status:	Listed, Section 27 Part IV
Date:	1869
Architectural Style /	Vernacular, Gothic Revival
Influence:	
Floorplan:	Rectangular with rear wing addition
Storeys:	1
Foundation:	Unknown
Main Exterior Walls:	Aluminum siding
Roof:	Steep front gable
Typical Window:	Triangular opening, sash window
Main Entrance:	Flat, solid single leaf door with side light
	and plain trim
Main Stairs/Porch:	Concrete 6 step porch
Other Buildings:	N/A
Landscape Features:	Mature deciduous and coniferous trees
	to the southeast and southwest of the
	building
Other Property	N/A
Features:

History Summary:	St. James the Apostle Anglican Church, designed by John T. Stokes. Aerial photographs and satellite images identify that the Parish Hall –at the back of the property—was built between 1956 and 1970.  This is an institutional building.
Thematic Framework:	Religious, Social Development
Evaluation O. Reg. 9/06	This property meets five criteria of <i>O. Reg. 9/06</i> , including 1, 4, 6, 7, and 8.  The property has design value as a locally unique example of a modest frame church building. It has historical value as the church for the local Anglican community. It also demonstrates the work of architect John T. Stokes. It has contextual value because it defines and supports the character of the area and has visual and functional links with the adjacent parish house and has historical and visual links with Maplehyrn –across the street.

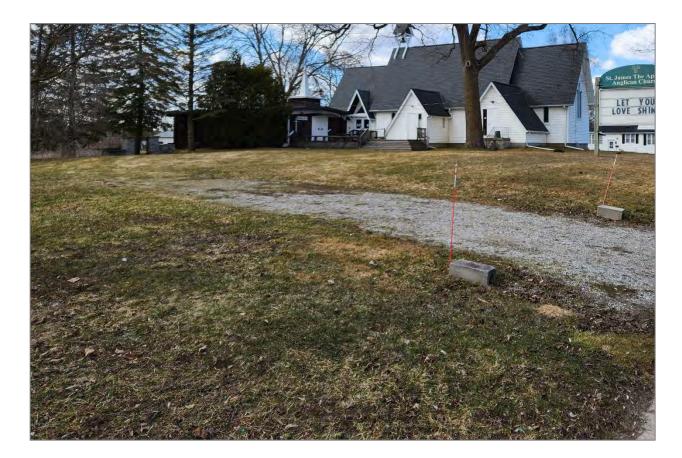
Duna a sutu a Managa	N1/A
Property Name:	N/A
Roll Number:	N/A
Heritage Status:	N/A
Date:	N/A
Architectural Style /	N/A
Influence:	
Floorplan:	N/A
Storeys:	N/A
Foundation:	N/A
Main Exterior Walls:	N/A
Roof:	N/A
Typical Window:	N/A
Main Entrance:	N/A
Main Stairs/Porch:	N/A
Other Buildings:	N/A
Landscape Features:	The back of the property is populated
	with mature coniferous and deciduous
	trees.
Other Property	N/A
Features:

History Summary:	Aerial photographs and satellite images show a building was situated near the northeast property line sometime between 1927-1945. By 1970 a second, smaller building was added south of the first building. The buildings remained on the lot until 1995.  This was a residential property. This property appears to be a parking area and open space attached to the adjacent church property.
Thematic Framework:	Religious, Social Development
Evaluation O. Reg. 9/06	This Property does not meet any criteria of O. Reg. 9/06.

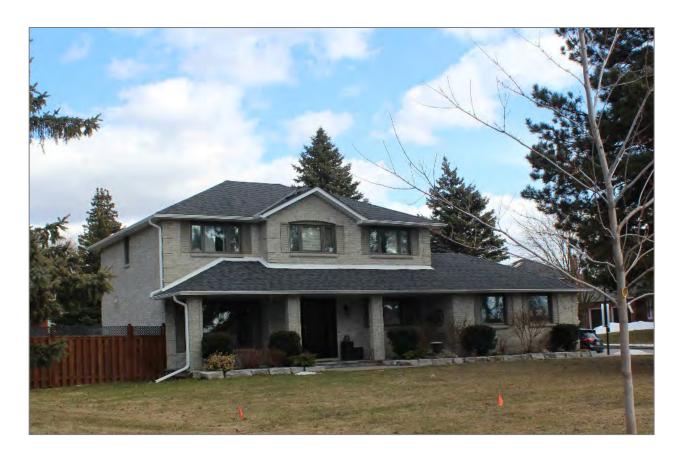
## **4 Ward Avenue**

Property Name:	N/A
Roll Number:	N/A
Heritage Status:	N/A
Date:	1978-1987
Architectural Style /	Vernacular
Influence:	
Floorplan:	Square
Storeys:	2
Foundation:	Unknown
<b>Main Exterior Walls:</b>	Brick
Roof:	Hipped
Typical Window:	Rectangular or segmentally arched,
	casement with plain trim and concrete
	lug sill
Main Entrance:	Solid, single leaf door with sidelights
	and plain trim; centre hall
Main Stairs/Porch:	At-grade porch with hipped roof
	extends along the southwest elevation
	of the main building
Other Buildings:	N/A
Landscape Features:	Mature deciduous and coniferous trees
	extend along the northwest property
	line and are intermittently located
	throughout the property
Other Property	N/A
Features:

History Summary:	This property is on Lot 9 Concession 3. In 1857 Humphry Finch was the owner of the land. By 1860 John Doan owned it. By 1878 Jesse Doan owned it. This property appears to have been used as a field. Aerial photographs and satellite images do not show any buildings or structures on the property until 1988. Built as part of the Sharon Hills residential subdivision.  This is a residential property.
Thematic	N/A
Framework:	
Evaluation	This property does not meet any of the criteria from O. Reg. 9/06.
O. Reg. 9/06

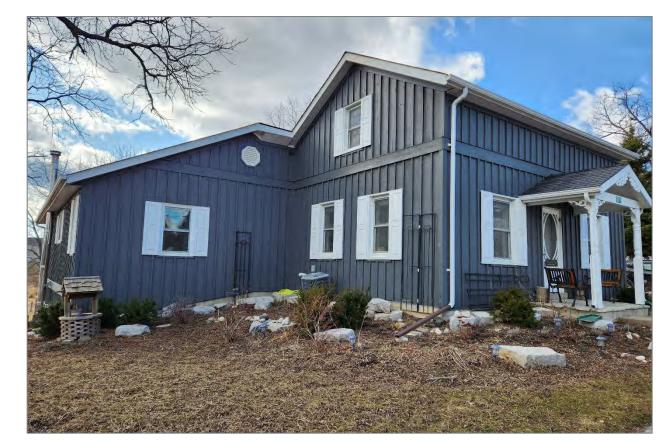
<del>-</del>
Property Name:	Anna Dunham House, William Graham
	House, William Thorpe House
Roll Number:	1954-000-220-346-00
Heritage Status:	Listed, Section 27 Part IV
Date:	c. 1880
Architectural Style /	Vernacular, Gothic Revival influences
Influence:	
Floorplan:	Rectangular with rear and side
	additions
Storeys:	1.5
Foundation:	Unknown
Main Exterior Walls:	Wood board and batten
Roof:	Side gable with overhanging eaves
Typical Window:	Rectangular, sash, 1/1 window with
	plain trim and storm shutters
Main Entrance:	Flat, single leaf door with central
	glazing and simple trim
Main Stairs/Porch:	Concrete 3 step porch with gable roof
	supported by decorated posts.
	Decorative wood trim is situated along
	and within the roof
Other Buildings:	N/A
Landscape Features:	Mature deciduous and coniferous tress
	along the southeast, southwest, and
	northwest elevation
Other Property	N/A
Features:

Residence of several inhabitants of Sharon including Anna Dunham, the daughter of Robert and Anna Briggs and wife of Elijah Dunham; William Graham, a local farmer; and William Thorpe.xxxix

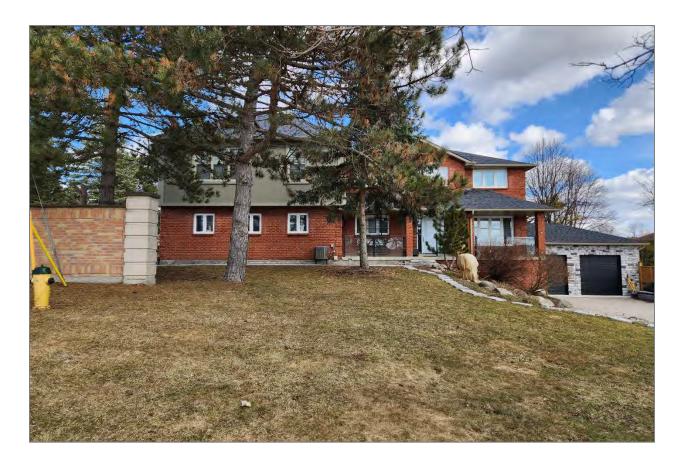
## 3 Ward Avenue

Property Name:	N/A
Roll Number:	N/A
Heritage Status:	N/A
Date:	1978-1987
Architectural Style /	Vernacular
Influence:	
Floorplan:	Rectangular
Storeys:	2
Foundation:	Concrete
Main Exterior Walls:	Brick, stone veneer, stucco
Roof:	Hipped
Typical Window:	Rectangular, casement with simple white trim and brick sill
Main Entrance:	Single leaf door both with white trim and sidelights; center hall
Main Stairs/Porch:	Concrete 2 step porch covered with a hipped roof supported by brick columns
Other Buildings:	N/A
Landscape Features:	Mature deciduous and coniferous trees are interspersed throughout the property
Other Property	N/A
Features:

History	This property is on Lot 9 Concession 3. In 1857 Humphry Finch was the owner
Summary:	of the land. By 1860 John Doan owned it. By 1878 Jesse Doan owned it. This property appears to have been used as a field. Aerial photographs and satellite images do not show any buildings or structures on the property until 1988. Built as part of the Sharon Hills residential subdivision.  This is a residential property.
Thematic	N/A
Framework:	
Evaluation	This property does not meet any of the criteria from O. Reg. 9/06.
O. Reg. 9/06

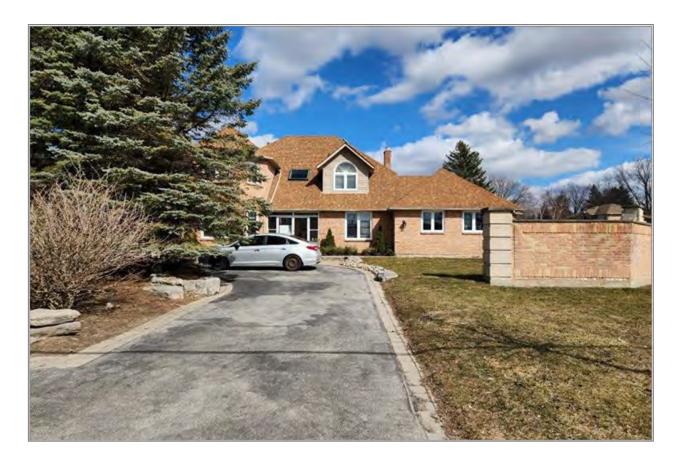
## 4 Arthur Hall Drive

Property Name:	N/A
Roll Number:	N/A
Heritage Status:	N/A
Date:	1978-1987
Architectural Style /	Vernacular
Influence:	
Floorplan:	Rectangular
Storeys:	2
Foundation:	Concrete
<b>Main Exterior Walls:</b>	Concrete – Red Brick
Roof:	Hipped
Typical Window:	Rectangular, sash with white trim and
	plain concrete lug sill
Main Entrance:	Flat, two leaf door both with central
	glazing, transom, and sidelights; side hall
Main Stairs/Porch:	Stone 1 step entrance
Other Buildings:	N/A
Landscape Features:	Mature deciduous and coniferous trees
	interspersed throughout the property
Other Property	Driveway
Features:

History	This property is on Lot 9 Concession 3. In 1857 Humphry Finch was the owner	
Summary:	of the land. By 1860 John Doan owned it. By 1878 Jesse Doan owned it. This property appears to have been used as a field. Aerial photographs and satellite images do not show any buildings or structures on the property until 1988. Built as part of the Sharon Hills residential subdivision.  This is a residential property.	
Thematic	N/A	
Framework:		
Evaluation	This property does not meet any of the criteria from O. Reg. 9/06.	
O. Reg. 9/06

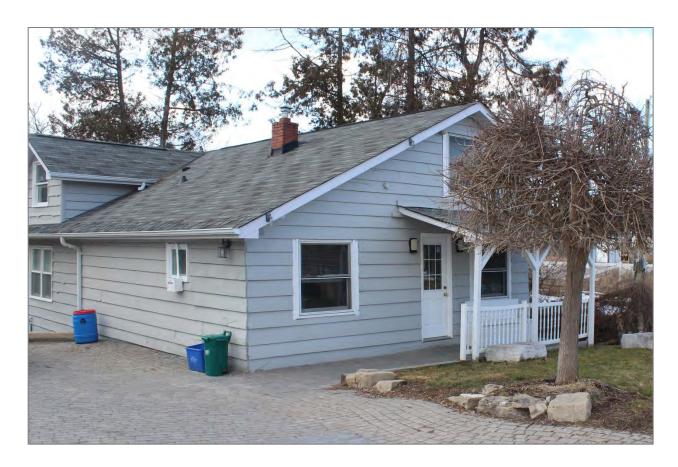
Duan out - Nouse	Charan Vatarinam, Clinia
Property Name:	Sharon Veterinary Clinic
Roll Number:	N/A
Heritage Status:	N/A
Date:	Pre-1927
Architectural Style /	Ontario Vernacular
Influence:	
Floorplan:	Rectangular
Storeys:	1.5
Foundation:	Unknown
Main Exterior Walls:	Vinyl siding
Roof:	Front gable, gable dormer on the
	southeast elevation
Typical Window:	Rectangular, sash, 1/1 window with
	plain trim
Main Entrance:	Flat, single leaf door with central
	glazing and plain trim
Main Stairs/Porch:	At-grade porch with shed roof
	supported by square posts with
	brackets
Other Buildings:	N/A
Landscape Features:	Small garden towards the northeast
	property line, mature coniferous and
	deciduous trees to the southeast,
	southwest, and northwest property
	lines
Other Property	N/A
Features:

History Summary:	Aerial photographs and satellite images identify that no major discernable alterations have been made to the property since 1927. A small parking area accessible from Leslie Street was built 1999.	
	This is a commercial property that formerly served a residential purpose.	
Thematic Framework:	N/A	
Evaluation O. Reg. 9/06	This property meets criteria 7 of <i>O. Reg. 9/06</i> . It has contextual value because it supports the character of the area.	
	However, this property is somewhat isolated from the rest of the village and the large parking area, naturalized area behind it and proximity to the creek contribute to a rural character as well.

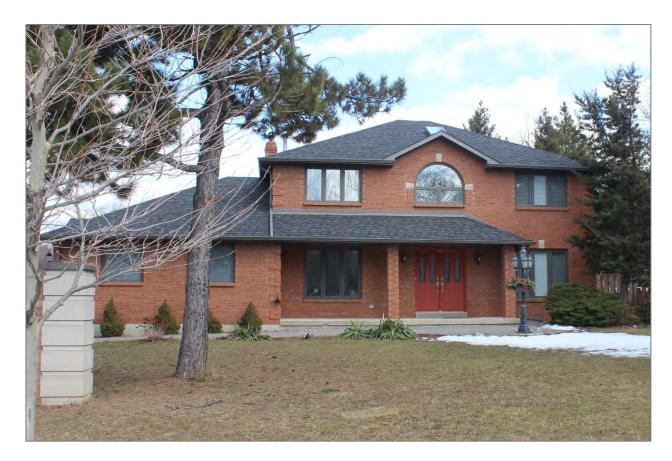
## 3 Arthur Hall Drive

Property Name:	N/A
Roll Number:	N/A
Heritage Status:	N/A
Date:	1978-1987
Architectural Style /	Vernacular
Influence:	
Floorplan:	Rectangular
Storeys:	2
Foundation:	Concrete
Main Exterior Walls:	Brick – Red Concrete
Roof:	Hipped
Typical Window:	Rectangular, casement with grey trim
	and brick sill
Main Entrance:	Double leaf door both with central
	glazing; center hall
Main Stairs/Porch:	Concrete 1 step porch covered with a
	hipped roof supported by brick columns
Other Buildings:	N/A
Landscape Features:	Mature deciduous and coniferous trees
	extend along the southeast property
	line and are interspersed throughout
	the property
Other Property	N/A
Features:

History	This property is on Lot 9 Concession 3. In 1857 Humphry Finch was the owner	
Summary:	of the land. By 1860 John Doan owned it. By 1878 Jesse Doan owned it. This property appears to have been used as a field. Aerial photographs and satellite images do not show any buildings or structures on the property until 1988. Built as part of the Sharon Hills residential subdivision.  This is a residential property.	
Thematic	N/A	
Framework:		
Evaluation	This property does not meet any of the criteria from O. Reg. 9/06.	
O. Reg. 9/06

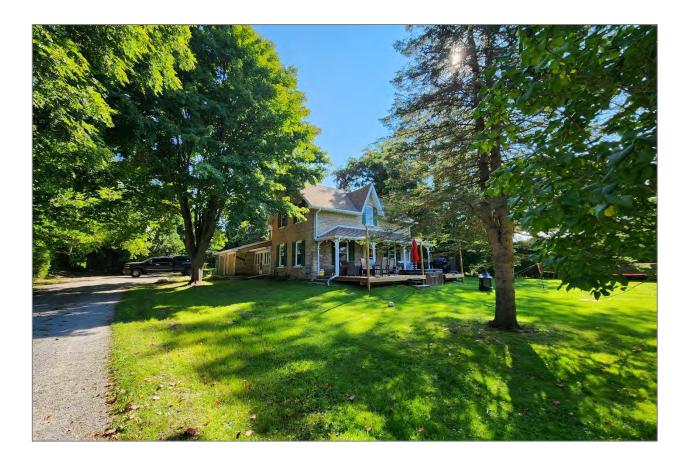
Property Name:	William Lane Knight House
Roll Number:	1954-000-220-995-00
Heritage Status:	Listed, Section 27 Part IV
Date:	1860
Architectural Style /	Vernacular; Gothic Revival
Influence:	
Floorplan:	T-Shape with rear wing addition
Storeys:	1.5
Foundation:	Unknown
Main Exterior Walls:	Brick – Buff
Roof:	Gable
Typical Window:	Unknown
Main Entrance:	Centre Hall
Main Stairs/Porch:	Front – Across All
Other Buildings:	N/A
Landscape Features:	Mature deciduous and coniferous trees
	extend along the northeast, part of the
	southeast, and northwest property lines
Other Property	N/A
Features:

History Summary:	Built by John Doan; William Lane Knight was a Warden, and the Knight family was highly-respected part of this community as pillars in the Anglican Church congregation. Aerial photographs and satellite images identify that an addition was added to the building by 1988.  This is a residential property.
Thematic Framework:	Religious, Social Development
Evaluation O. Reg. 9/06	This property meets two criteria of <i>O. Reg. 9/06</i> , including criteria 1 and 4. The property has physical value because it is a representative example of a regional variation of the Gothic Revival architectural style. It has historical value because it is associated by John Doan and William Lane Knight. The style of house and setback from the street are more consistent with an agricultural or rural property than with the character of most of the village.

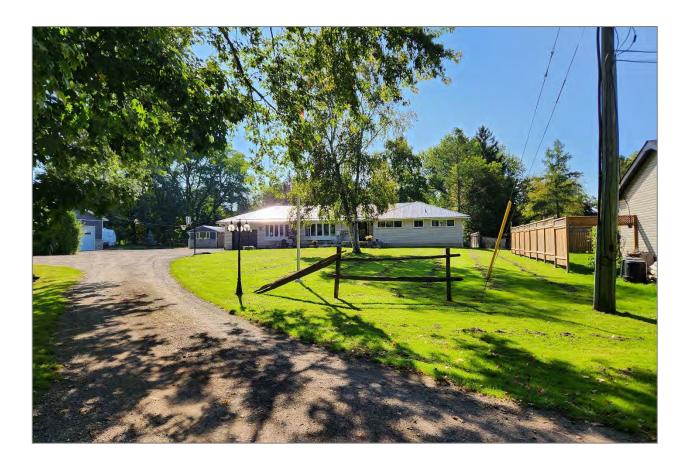
Property Name:	N/A
Roll Number:	N/A
Heritage Status:	N/A
Date:	1970-1978
Architectural Style /	Vernacular
Influence:	
Floorplan:	Rectangular
Storeys:	1
Foundation:	Unknown
Main Exterior Walls:	Brick
Roof:	Hipped
Typical Window:	Rectangular, casement with white trim
	and decorative storm shutters
Main Entrance:	Side Hall
Main Stairs/Porch:	Unknown
Other Buildings:	Large garage to the northeast of the
	main building; shed to the east of the
<u></u>	main building
Landscape Features:	Mature deciduous and coniferous trees
	interspersed across the property
Other Property	N/A
Features:

History Summary:	This property is on Lot 8 Concession 3. In 1857 William Hughes was the owner of the land. Between 1860 and 1878 William Knight owned it. This property appears to have been used as a field. Aerial photographs and satellite images do not show any buildings or structures on the property until 1978. A large garage was built in 2020.  This is a residential property.
Thematic	N/A
Framework:	
Evaluation	This property does not meet any of the criteria from O. Reg. 9/06.
O. Reg. 9/06

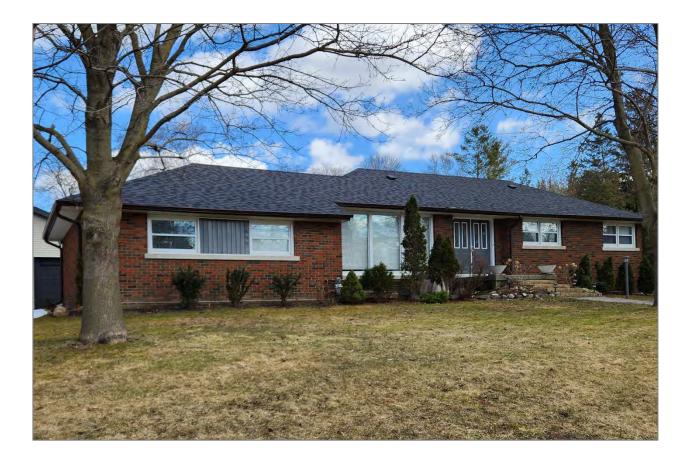
Property Name:	N/A
Roll Number:	N/A
Heritage Status:	N/A
Date:	1954-1960
Architectural Style /	Vernacular
Influence:	
Floorplan:	Rectangular
Storeys:	1
Foundation:	Unknown
Main Exterior Walls:	Brick – Red Concrete
Roof:	Hipped
Typical Window:	Rectangular, sash with white trim and
	plain concrete lug sill
Main Entrance:	Flat, double leaf door each with central
	glazing in simple trim; centre hall
Main Stairs/Porch:	Stone 5 step entrance
Other Buildings:	Large garage to the east of the main
	building
Landscape Features:	Mature deciduous trees interspersed
	throughout the property
Other Property	N/A
Features:

History Summary:	This property is on Lot 8 Concession 3. In 1857 William Hughes was the owner of the land. Between 1860 and 1878 William Knight owned it. This property appears to have been used as a field. Aerial photographs and satellite images do not show any buildings or structures on the property until 1970. A large garage was built by 2020.  This is a residential property.	
Thematic	N/A	
Framework:		
Evaluation	This property does not meet any of the criteria from O. Reg. 9/06.	
O. Reg. 9/06

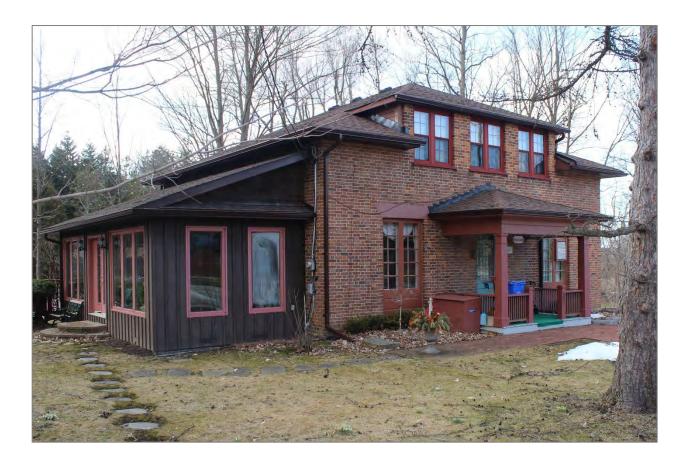
Property Name:	Peter Rowan House, Woodlawn of the
	Oxtoby House
Roll Number:	1954-000-220-270-00
Heritage Status:	Listed, Section 27 Part IV
Date:	1843
Architectural Style /	Vernacular, Regency Cottage
Influence:	
Floorplan:	Square with side wing addition
Storeys:	2
Foundation:	Unknown
Main Exterior Walls:	Red brick, board and batten
Roof:	Low hip
Typical Window:	Rectangular, sash, 4/4 window with
	plain trim
Main Entrance:	Flat, single leaf door with central
	glazing and plain trim
Main Stairs/Porch:	Single wood step porch covered by a
	hip roof supported by square posts
Other Buildings:	Large shed to the west of the building
Landscape Features:	Heavily populated with mature
	deciduous and coniferous trees
Other Property	N/A
Features:

History Summary:	Residence of Peter Rowan, a member of the Children of Peace. Rowan was a wheelwright and blacksmith. It is possible that Rowan produced pikes for those who partook in the Rebellions of 1837-1838. The frame driving shed was the site of a shop. *Ii Aerial photographs and satellite images identify that no major alterations have occurred on the property.  This is a residential property.
Thematic Framework:	Religious, Social Development Political
Evaluation O. Reg. 9/06	This property meets three criteria of <i>O. Reg. 9/06</i> , including 1, 4 and 7. It has design value as a unique example of a cottage style house in Sharon. It has historical value because of its association with Peter Rowan. It has contextual value because it supports the character of the area. The property is heavily naturalized which contributes to it having rural characteristics as well.

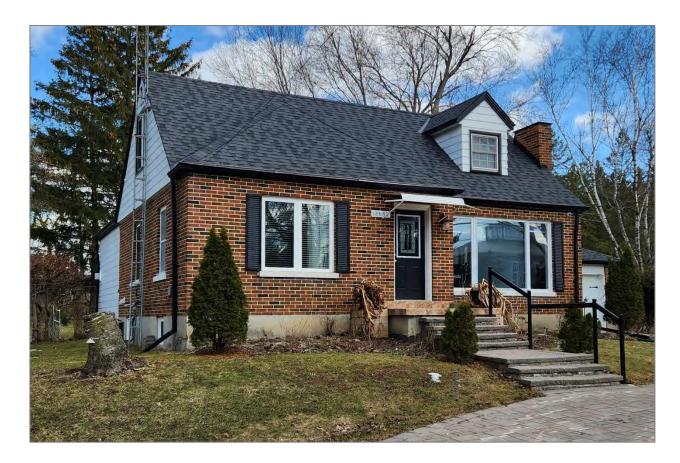
Property Name:	N/A
Roll Number:	N/A
Heritage Status:	N/A
Date:	1954-1960
Architectural Style /	Vernacular
Influence:	
Floorplan:	Rectangular with rear wing addition
Storeys:	1.5
Foundation:	Concrete
Main Exterior Walls:	Siding – Vinyl; Brick – Red Concrete
Roof:	Side gable with offset gabled dormer
	and chimney
Typical Window:	Rectangular, casement with white trim,
	atauna akuuttana analudatu aananata lua
	storm shutters, and plain concrete lug
	sills
Main Entrance:	
Main Entrance:	sills
Main Entrance:  Main Stairs/Porch:	sills Flat, single leaf door with central
	sills Flat, single leaf door with central glazing and plain trim; centre hall
	sills  Flat, single leaf door with central glazing and plain trim; centre hall  Stone and wood 9 step entrance; small
Main Stairs/Porch:	sills  Flat, single leaf door with central glazing and plain trim; centre hall  Stone and wood 9 step entrance; small awning
Main Stairs/Porch:	sills  Flat, single leaf door with central glazing and plain trim; centre hall  Stone and wood 9 step entrance; small awning  Large garage with hipped roof to the

Main Stairs/Porch: Other Buildings:	sills  Flat, single leaf door with central glazing and plain trim; centre hall  Stone and wood 9 step entrance; small awning  Large garage with hipped roof to the east of the main building
Main Stairs/Porch: Other Buildings:	sills  Flat, single leaf door with central glazing and plain trim; centre hall  Stone and wood 9 step entrance; small awning  Large garage with hipped roof to the east of the main building  Mature deciduous and coniferous trees

History Summary:	This property is on Lot 8 Concession 3. In 1857 William Hughes was the owner of the land. Between 1860 and 1878 William Knight owned it. This property appears to have been used as a field. Aerial photographs and satellite images do not show any buildings or structures on the property until 1970. A rear addition was built prior to 1978.  This is a residential property.
Thematic	N/A
Framework:	
Evaluation	This property does not meet any of the criteria from O. Reg. 9/06.
O. Reg. 9/06

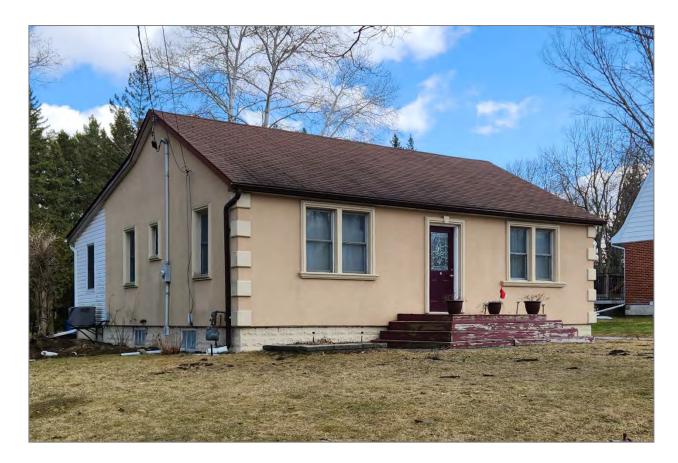
-	
Property Name:	N/A
Roll Number:	N/A
Heritage Status:	N/A
Date:	1946-1953
Architectural Style /	Vernacular
Influence:	
Floorplan:	Square with rear addition
Storeys:	1
Foundation:	Unknown
Main Exterior Walls:	Stucco
Roof:	Side gable
Typical Window:	Rectangular, sash with beige trim and
	sill
Main Entrance:	Flat, single leaf door with central
	glazing and decorative beige trim;
	centre hall
Main Stairs/Porch:	Wood 4 step entrance
Other Buildings:	Garage to the east of the main building
Landscape Features:	Mature deciduous and coniferous trees
	to the interspersed through the
	property
Other Property	N/A
Features:

History Summary:	This property is on Lot 8 Concession 3. In 1857 William Hughes was the owner of the land. Between 1860 and 1878 William Knight owned it. This property appears to have been used as a field. Aerial photographs and satellite images do not show any buildings or structures on the property until 1954. A rear addition was built prior to 2005.  This is a residential property.
Thematic	N/A
Framework:	
Evaluation	This property does not meet any of the criteria from O. Reg. 9/06.
O. Reg. 9/06
