# **Sharon Heritage Conservation District Study**

**Volume III**

# **Individual Property Inventory and Evaluation**

East Gwillimbury, Ontario

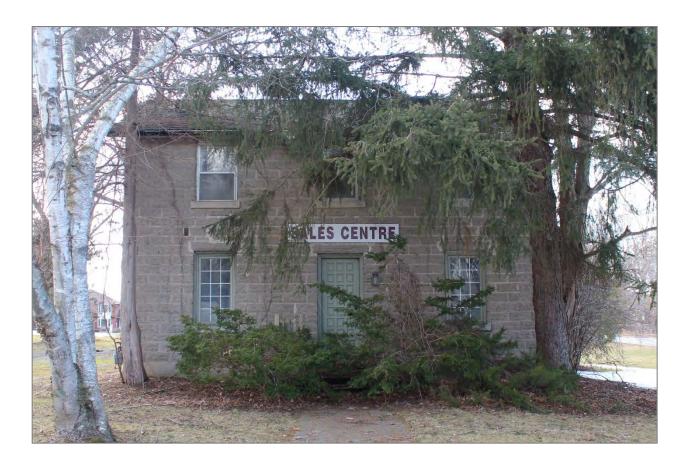
Property Name:	William Henry Rowan House
Roll Number:	1954-000-220-227-00
Heritage Status:	Listed, Section 27 Part IV
Date:	Pre-1927
Architectural Style /	Vernacular; Classical Revival
Influence:	
Floorplan:	Rectangular
Storeys:	2
Foundation:	Likely Concrete – could be stone, well parged.
Main Exterior Walls:	Even course rusticated concrete block.
Roof:	Side gable
Typical Window:	Rectangular, sash, 3x5 pane
	arrangement with cut stone header and
	sill
Main Entrance:	Flat, solid single leaf door with cut
	stone header
Main Stairs/Porch:	Unknown
Other Buildings:	N/A
Landscape Features:	Mature deciduous trees intermittently
	located around the main house. Young
	coniferous trees line the southeast
	property line and young deciduous
	trees line the northwest property line
Other Property	N/A
Features:

This property originally included the residence of William Henry Rowan, a wheelwright and son of Peter Rowan.xiii It is unknown when the current building was built, however it may be visible on a 1927 aerial photograph and is visible on a 1946 aerial photograph. Rusticated concrete block was developed in the late 19th century and was popular in Ontario between 1905 and 1930. The overall form of the building appears consistent with a 19th century date. It is possible a 19th century house was reclad in a "modern" material in the early 20th century. Aerial photographs show that the property was a farm with a residence, a barn, a silo and several outbuilding. Aerial photographs and satellite images identify that the farm was levelled by 1988 with only the residence remaining.

# Evaluation O. Reg. 9/06 This property meets two criteria O. Reg. 9/06, including criteria 1 and 7. It has physical value because it is a rare example of a building clad in rusticated concrete block in the area. It has contextual value because it supports the character of the area. However, the large lot with mature trees

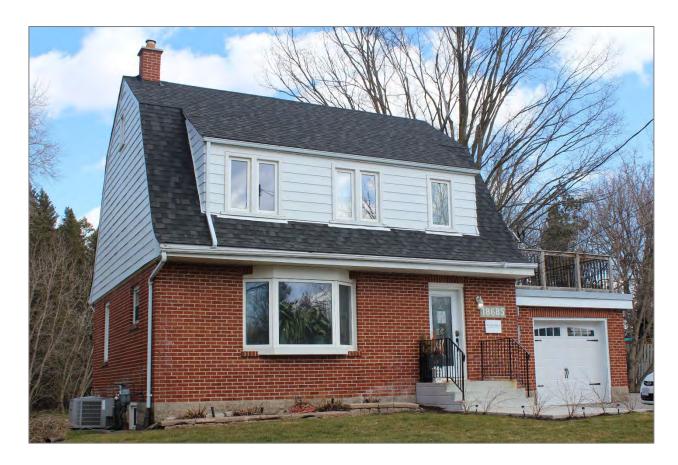
Property Name:	N/A
Roll Number:	N/A
Heritage Status:	N/A
Date:	1946-1953
Architectural Style /	Vernacular, Dutch Revival
Influence:	
Floorplan:	Square with side wing, garage addition
Storeys:	2
Foundation:	Unknown
<b>Main Exterior Walls:</b>	Siding – Vinyl; Brick – Red Concrete
Roof:	Gambrel with shed dormer and red
	brick chimney
Typical Window:	Rectangular, casement with white trim
	and plain sills
Main Entrance:	Flat, single leaf door with central
	glazing and plain trim; centre hall
Main Stairs/Porch:	Concrete 3 step entrance
Other Buildings:	N/A
Landscape Features:	Mature deciduous and coniferous trees
	interspersed throughout the property
Other Property	N/A
Features:

History Summary:	This property is on Lot 8 Concession 3. In 1857 William Hughes was the owner of the land. Between 1860 and 1878 William Knight owned it. This property appears to have been used as a field. Aerial photographs and satellite images do not show any buildings or structures on the property until 1954.  This is a residential property.
Thematic	N/A
Framework:	
Evaluation	This property does not meet any of the criteria from O. Reg. 9/06.
O. Reg. 9/06

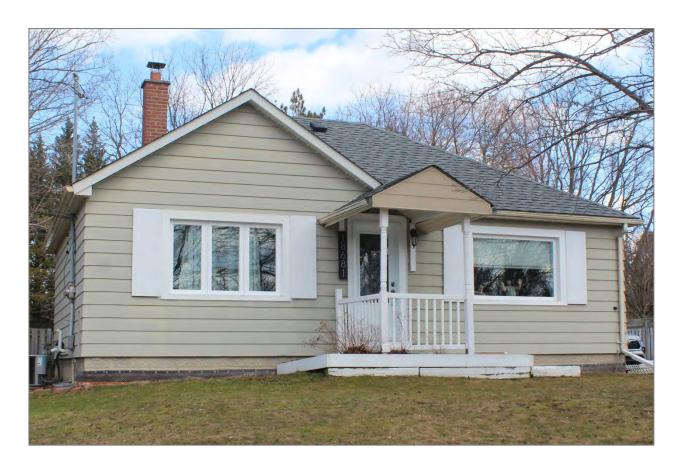
Property Name:	N/A
Roll Number:	N/A
Heritage Status:	N/A
Date:	1946-1953
Architectural Style /	Vernacular, Minimal Traditional
Influence:	
Floorplan:	L-Shape with rear addition
Storeys:	1
Foundation:	Unknown
Main Exterior Walls:	Siding – Vinyl
Roof:	Complex with red brick chimney
Typical Window:	Rectangular, casement with white trim
	and decorative storm shutters
Main Entrance:	Flat, single leaf door with central
	glazing; centre hall
Main Stairs/Porch:	Wood 2 step porch covered by a
	square, front gable roof supported by
	decorative posts
Other Buildings:	Garage to the east of the main building
Landscape Features:	Mature deciduous trees interspersed
	throughout the property
Other Property	N/A
Features:

History Summary:	This property is on Lot 8 Concession 3. In 1857 William Hughes was the owner of the land. Between 1860 and 1878 William Knight owned it. This property appears to have been used as a field. Aerial photographs and satellite images do not show any buildings or structures on the property until 1954. A rear addition was built prior to 2005.  This is a residential property.	
Thematic	N/A	
Framework:		
Evaluation	This property meets criteria 7 of <i>O. Reg. 9/06</i> . It supports the character of the	
O. Reg. 9/06	area.

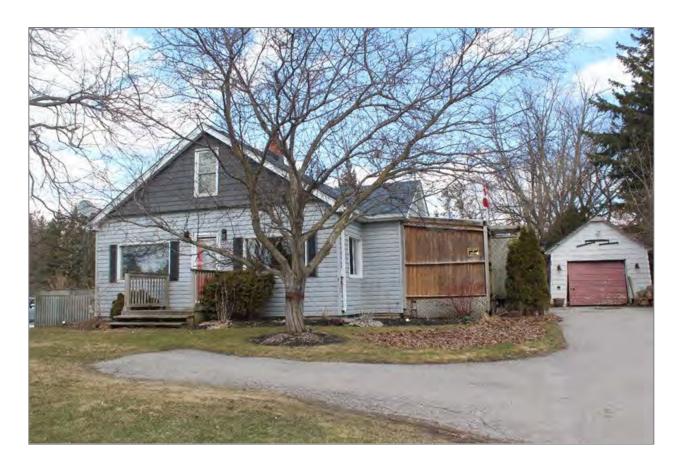
Property Name:	N/A
Roll Number:	N/A
Heritage Status:	N/A
Date:	1946-1953
Architectural Style /	Vernacular, Minimal Traditional
Influence:	
Floorplan:	Square with addition
Storeys:	1.5
Foundation:	Unknown
Main Exterior Walls:	Siding – Vinyl
Roof:	Front gable with red brick chimney
Typical Window:	Rectangular, sash with white trim
Main Entrance:	Flat, single leaf door with central
	glazing and decorative wood trim;
	centre hall
Main Stairs/Porch:	Wood 3 step porch, uncovered
Other Buildings:	Garage to the east of the main building
Landscape Features:	Mature deciduous trees interspersed
	throughout the property
Other Property	N/A
Features:

History Summary:	This property is on Lot 8 Concession 3. In 1857 William Hughes was the owner of the land. Between 1860 and 1878 William Knight owned it. This property appears to have been used as a field. Aerial photographs and satellite images do not show any buildings or structures on the property until 1927.  This is a residential property.
Thematic	N/A
Framework:	
Evaluation	This property meets criteria 7 of <i>O. Reg. 9/06</i> . It supports the character of the
O. Reg. 9/06	area.

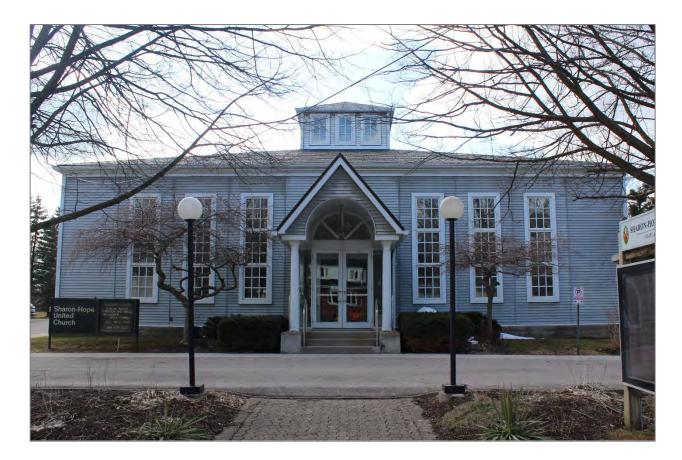
Property Name: Roll Number:	Sharon-Hope United Church
Roll Number:	
	N/A
Heritage Status:	N/A
Date:	1987
Architectural Style /	N/A
Influence:	
Floorplan:	Square with rear wing additions
Storeys:	2
Foundation:	Unknown
Main Exterior Walls:	Clapboard siding
Roof:	Hipped with square belvedere, centre
	gable, hipped gable
Typical Window:	Rectangular, sash, simple trim
Main Entrance:	Flat, two leaves with central glazing,
	side lights, and shaped four light
	transom
Main Stairs/Porch:	Steeply pitched, front gable porch
	supported on either side by Doric
	columns. Concrete 3 step porch
Other Buildings:	N/A
Landscape Features:	Mature deciduous and coniferous trees
	line the northeast, northwest, and
	southwest property lines. Young
	coniferous trees line the southeast
	property line
Other Property	Small playground in the property's
Features:	northwest corner

History	The Sharon Methodist Church was first established to the north of Sharon in
Summary:	the 1850s. The church moved to Leslie Street in 1867. In 1925, the Methodist Church amalgamated as part of the United Church. Sharon-Hope United Church built in 1987 to support the growth of the congregation. Aerial photographs and satellite images show that prior to the development of the church, a small building that fronted onto Leslie Street occupied the property. This is an institutional property that formerly served a residential purpose.
Thematic .	Religious, Social Development
Framework:	
Evaluation	This property meets three criteria of <i>O. Reg. 9/06</i> , including criteria 1, 4, 7

O. Reg. 9/06	and 9.
	It has physical value because it is a unique example of a relatively contemporary religious building in Sharon that drew inspiration from the Sharon Temple. It has historical value because it is associated with the United/Methodist church community in Sharon. It has contextual value because it supports the character of the area and is a minor landmark.

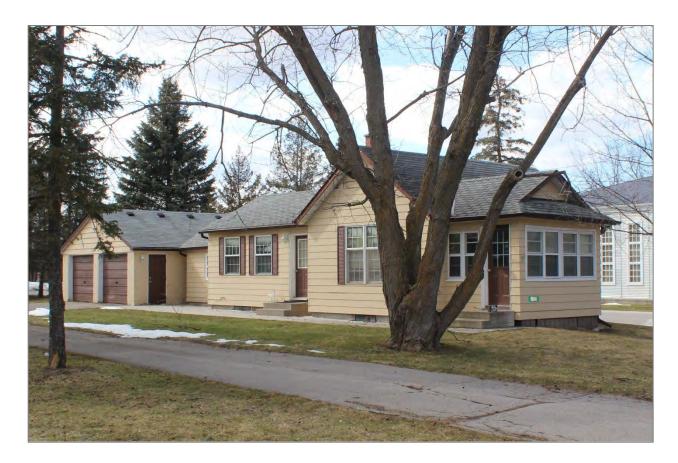
Property Name:	N/A
Roll Number:	N/A
Heritage Status:	N/A
Date:	Pre-1927
Architectural Style /	Vernacular, Minimal Traditional
Influence:	
Floorplan:	Rectangular with rear wing additions
Storeys:	1
Foundation:	Concrete
Main Exterior Walls:	Vinyl clapboard siding
Roof:	Side gable; gabled hip at main entrance
Typical Window:	Rectangular, sash, decorative storm
	shutters with no trim
Main Entrance:	Flat, single leaf door with central
	glazing in a 3x3 pattern and no trim
Main Stairs/Porch:	Concrete 2 step porch
Other Buildings:	N/A
Landscape Features:	Mature deciduous trees align the
	northeast, southeast, and southwest
	property lines. Young coniferous trees
	line the northwest property line
Other Property	N/A
Features:

History Summary:	This property is on Lot 8 Concession 2. Between 1860 and 1878 G.M. Doan owned it. This property appears to have been used as a field. Aerial photographs and satellite images show that a former rear addition was removed before 1978.  This is a residential property.	
Thematic Framework:	N/A	
Evaluation O. Reg. 9/06	This property meets criteria 7 of <i>O. Reg. 9/06</i> . It has contextual value because it supports the character of the area.	
	The size and style of the house is consistent with others in the village. However, this property is a large lot with large lawn that has rural characteristics.

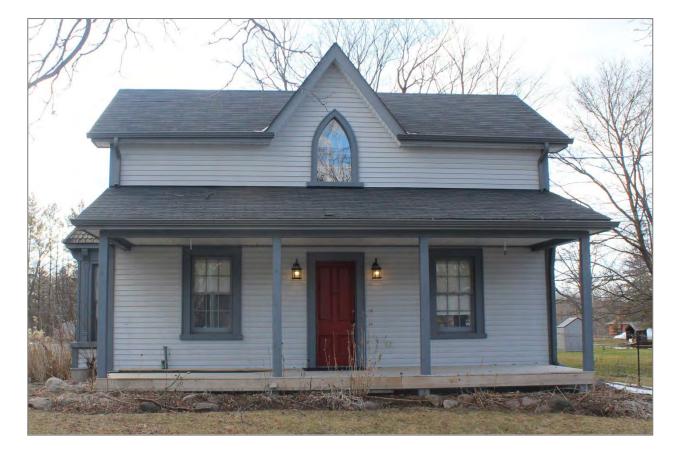
Property Name:	N/A
Roll Number:	1954-000-220-215-00
Heritage Status:	Listed, Section 27 Part IV
Date:	c. 1870
Architectural Style /	Vernacular; Gothic Revival
Influence:	
Floorplan:	Rectangular with rear wing additions
Storeys:	1.5
Foundation:	Unknown
Main Exterior Walls:	Aluminum clapboard siding
Roof:	Centre gable; gable
Typical Window:	Rectangular, sash, 6/6, with wood trim
	and wood lug sill
Main Entrance:	Rectangular, single leaf with wood trim
Main Stairs/Porch:	Full width front porch with shed roof
	supported by four wood posts accessed
	via two wooden stair risers on its
	northwest edge
Other Buildings:	N/A
Landscape Features:	Mature deciduous and coniferous trees
	line the property lines and are
	intermittently located towards the
	middle of the property
Other Property	N/A
Features:

History Summary:	This property is on Lot 8 Concession 2. Between 1860 and 1878 G.M. Doan owned it. Aerial photographs and satellite images identify that no major alteration on the property have occurred since 1927.  This is a residential property.
Thematic Framework:	N/A
Evaluation O. Reg. 9/06	This property meets two criteria of <i>O. Reg. 9/06</i> , including criteria 1 and 7. It has design value as a local representative example of a gothic revival cottage style house in the area. It has contextual value because the property supports the character of the area.
	The character of the area around this property is starting to show a clear shift away from the village character towards a more agricultural or rural character. The house and its setback from the street fit the village character but the large lot, curving gravel driveway and naturalized areas around the edges are starting to convey a rural or agricultural character more consistent with lots further south.

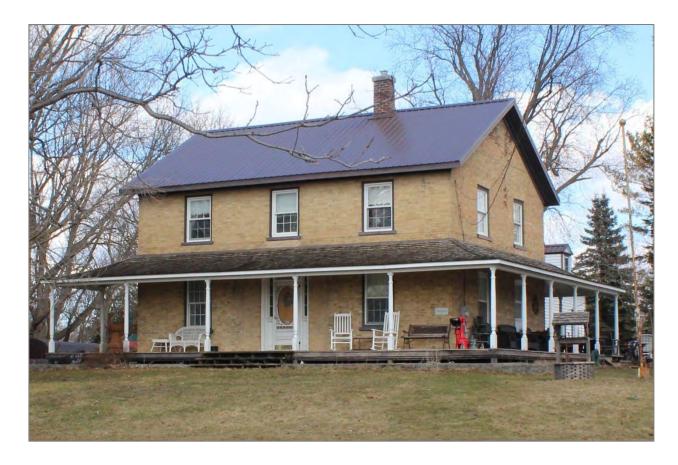
Property Name:	Col. James Wayling House
Roll Number:	1954-000-221-093-16
Heritage Status:	Listed, Section 27 Part IV
Date:	1855
Architectural Style /	Vernacular, Georgian
Influence:	
Floorplan:	Rectangular with rear wing addition
Storeys:	2
Foundation:	Unknown
Main Exterior Walls:	Brick - Buff
Roof:	Side gable with red brick chimney
Typical Window:	Rectangular, sash with brown trim and
	lug sill
Main Entrance:	Flat, solid single leaf door with
	sidelights; centre hall
Main Stairs/Porch:	Wood 3 step porch extending along the
	southeast and southwest elevations of
	the main building. Shed roof supported
	by decorative wood posts
Other Buildings:	Garage to the east of the main building
Landscape Features:	Mature deciduous and coniferous trees
	extend along the northeast and
	northwest property lines and are
	interspersed throughout the property
Other Property	N/A
Features:

History Summary:	This property was owned by the Wayling family. Several members of the Wayling family were awarded with military honours for their involvement in the Red River Rebellion, the Boer War, and World War I. XIIV Aerial photographs and satellite images identify that several garages have been constructed on the property, including one by 2002 and a second by 2011.
	This is a residential property.
Thematic	N/A
Framework:	
Evaluation	This property meets 3 criteria of <i>O. Reg. 9/06</i> , including 1, 4 and 7.

O. Reg. 9/06	It has design value as a locally representative example of a modest Georgian style house. It has historical value because of its connection to the Wayling family. It has contextual value because it supports the character of the area. The character of the area around this property is starting to show a clear shift away from the village character towards a more agricultural or rural character. The house and its setback from the street fit the village character but the large lot, curving gravel driveway and naturalized areas around the edges are starting to convey a rural or agricultural character more consistent with lots further south.

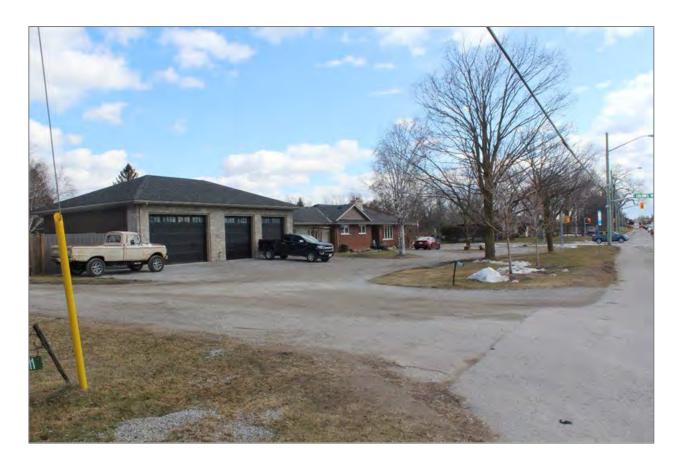
Property Name:	N/A
	•
Roll Number:	N/A
Heritage Status:	N/A
Date:	1970-1978
Architectural Style /	Vernacular
Influence:	
Floorplan:	Rectangular with side wing addition
	built between 2015 and 2016
Storeys:	1
Foundation:	Unknown
Main Exterior Walls:	Brick – Red Concrete
Roof:	Hipped
Typical Window:	Rectangular, casement with white trim
	and simple concrete lug sill
Main Entrance:	Flat, single leaf door with central
	glazing and sidelights; centre hall
Main Stairs/Porch:	Concrete 3 step entrance
Other Buildings:	Shed to the east of the main building
Landscape Features:	Mature deciduous and coniferous trees
	extend along the northeast and
	northwest property lines in the north
	corner of the property; mature
	deciduous and coniferous trees
	interspersed throughout the property
Other Property	None
Features:

History Summary:	This property is on Lot 8 Concession 3. In 1860 B. Lepard was the owner of the land. By 1878 James Wayling owned it. This property appears to have been used as a field. Aerial photographs and satellite images do not show any buildings or structures on the property until 1954. An addition was built prior to 2016.  This is a residential property.	
Thematic	N/A	
Framework:		
Evaluation	This property does not meet any of the criteria of O. Reg. 9/06	
O. Reg. 9/06

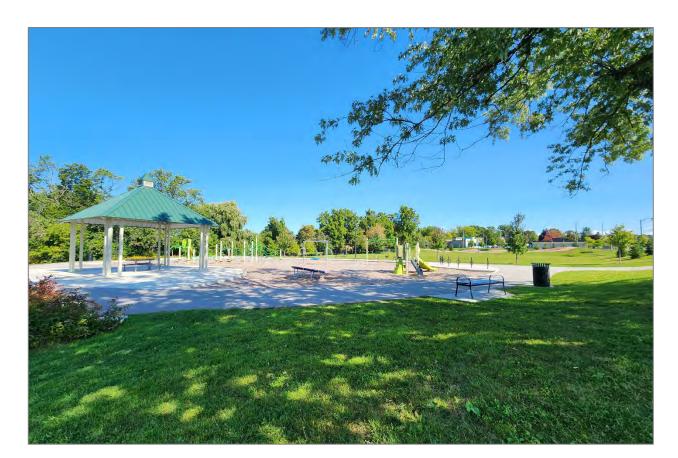
## **130 Manor Hampton Street**

Property Name:	Manor Hampton Park
Roll Number:	N/A
Heritage Status:	N/A
Date:	2019
Architectural Style /	N/A
Influence:	
Floorplan:	N/A
Storeys:	N/A
Foundation:	N/A
Main Exterior Walls:	N/A
Roof:	N/A
Typical Window:	N/A
Main Entrance:	N/A
Main Stairs/Porch:	N/A
Other Buildings:	Square gazebo with hipped roof and
	small playground
Landscape Features:	Asphalt walkway intermittently lined
	with stones and young deciduous and
	coniferous treed. Dirt, oval bike track
Other Property	N/A
Features:

This property is on Lot 8 Concession 2. Between 1860 and 1878 Charles
Haynes owned it. Aerial photographs and satellite images identify that no development occurred on the property until the area was graded for development between 2012 and 2013. The park was completed by 2019.  This is an open space property.
N/A
This property does not meet any of the criteria of O. Reg. 9/06

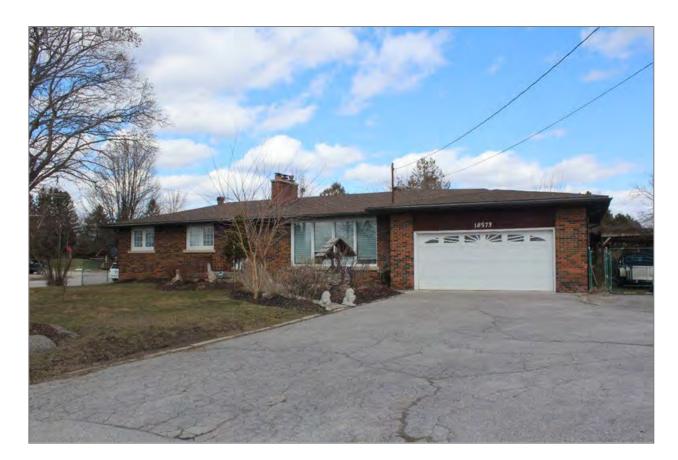
Property Name:	N/A
Roll Number:	N/A
Heritage Status:	N/A
Date:	1954-1960
Architectural Style /	Vernacular, Ranch
Influence:	
Floorplan:	Rectangular
Storeys:	1
Foundation:	Concrete
Main Exterior Walls:	Brick – Concrete
Roof:	Hipped with brick chimney
Typical Window:	Rectangular, casement with white trim
	and simple concrete lug sill
Main Entrance:	Flat, single leaf door with central
	glazing and simple trim; centre hall
Main Stairs/Porch:	Concrete step entrance
Other Buildings:	N/A
Landscape Features:	Mature deciduous and coniferous tress
	extend along all property lines
Other Property	N/A
Features:

History	This property is on Lot 8 Concession 3. In 1860 B. Lepard was the owner of	
Summary:	the land. By 1878 James Wayling owned it. This property appears to have been used as a field. Aerial photographs and satellite images do not show any buildings or structures on the property until 1970.	
	This is a residential property.	
Thematic	N/A	
Framework:		
Evaluation	This property does not meet any of the criteria of O. Reg. 9/06. This property	
O. Reg. 9/06	has a suburban or rural residential character that is very different from the rest of the Study Area.

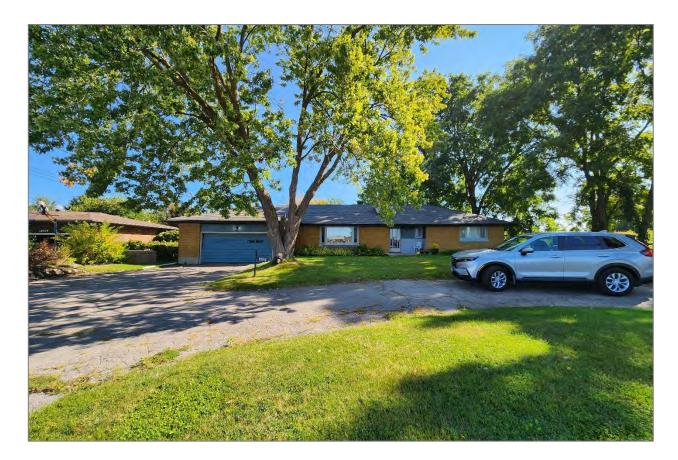
Property Name:	N/A
Roll Number:	N/A
Heritage Status:	N/A
Date:	1954-1960
Architectural Style /	Vernacular, Ranch
Influence:	
Floorplan:	Rectangular
Storeys:	1
Foundation:	Concrete
Main Exterior Walls:	Brick – Concrete
Roof:	Hipped with chimney
Typical Window:	Rectangular, casement with white trim
	and simple concrete lug sills
Main Entrance:	Flat, single leaf door with central
	glazing and simple trim; centre hall
Main Stairs/Porch:	Concrete 2 step entrance
Other Buildings:	N/A
Landscape Features:	Mature deciduous and coniferous trees extend along the southeast property line and are interspersed throughout the property
Other Property	N/A
Features:

History Summary:	This property is on Lot 8 Concession 3. In 1860 B. Lepard was the owner of the land. By 1878 James Wayling owned it. This property appears to have been used as a field. Aerial photographs and satellite images do not show any buildings or structures on the property until 1970.  This is a residential property.
Thematic Framework:	N/A
Evaluation O. Reg. 9/06	This property does not meet any of the criteria of <i>O. Reg. 9/06</i> . This property has a suburban or rural residential character that is very different from the rest of the Study Area.

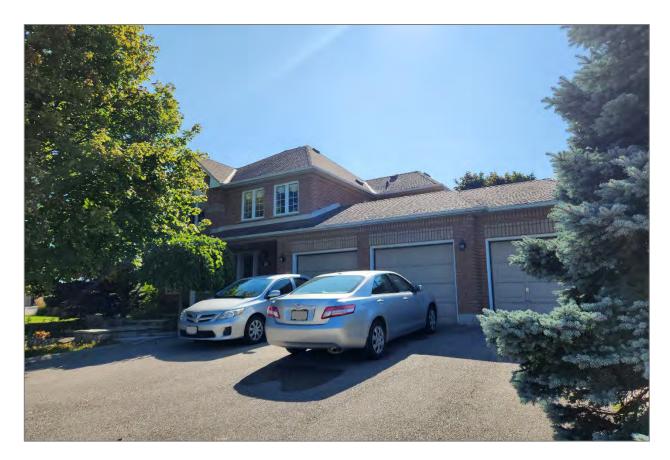
## **5 Colonel Wayling Blvd**

Property Name:	N/A
Roll Number:	N/A
Heritage Status:	N/A
Date:	1995-1999
Architectural Style / Influence:	Vernacular
Floorplan:	Irregular
Storeys:	2
Foundation:	Concrete
Main Exterior Walls:	Brick
Roof:	Medium hip
Typical Window:	Rectangular, casement with white trim and simple concrete lug sills
Main Entrance:	Flat, single leaf door with central glazing, sidelights, and simple trim; centre hall
Main Stairs/Porch:	Stone 5 step stair and partial width porch
Other Buildings:	Two small sheds to the south of the main residence; in-ground pool
Landscape Features:	Mature deciduous and coniferous trees line the northeast, southeast, and southwest property lines and are intermittently placed throughout the property's interior
Other Property Features:	N/A

History	This property is on Lot 8 Concession 3. In 1860 B. Lepard was the owner of	
Summary:	the land. By 1878 James Wayling owned it. This property appears to have been used as a field. Aerial photographs and satellite images do not show a buildings or structures on the property until 1999.	
	This is a residential property.	
Thematic	N/A	
Framework:		
Evaluation	This property does not meet any of the criteria of O. Reg. 9/06. The character	
O. Reg. 9/06	of this property is suburban.

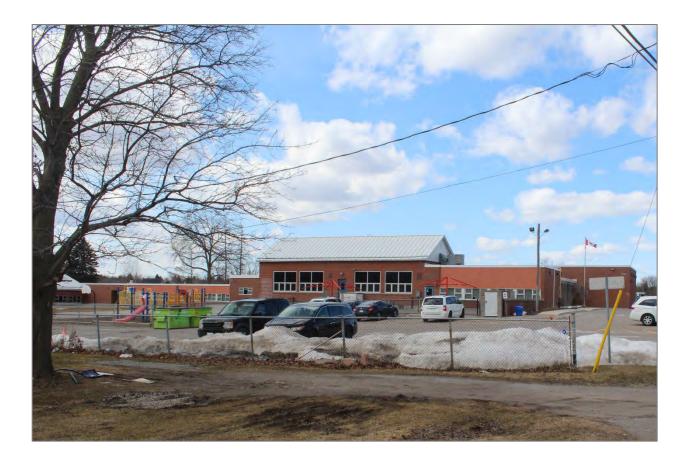
Property Name:	Sharon Public School
Roll Number:	1954-000-220-135-00
Heritage Status:	Listed, Section 27 Part IV
Date:	1966.
	Originally built in 1858, extensive
	additions were added in
	1954/1964/1966/2000.
Architectural Style /	Modernist, Mid-century school
Influence:	
Floorplan:	Irregular with side and rear additions
Storeys:	1
Foundation:	Concrete
Main Exterior Walls:	Red brick
Roof:	Complex: flat and front gable
Typical Window:	Rectangular, sash with concrete sill
Main Entrance:	Two offset entrances on the northeast
	elevation. Two leaves with flat openings
	and transom lights
Main Stairs/Porch:	Main entrances are at grade. A shallow
	stepback is covered with a flat roof.
	Eight concrete posts support the roof
	over the stepback
Other Buildings:	N/A
Landscape Features:	Mature deciduous trees line the
	property's southeast and southwest
	property lines. Fewer, younger
	deciduous and coniferous trees line the
	property's northwest property line.

History Summary:	Sharon Public School was officially opened in 1858 (then known as 'S.S. No. 4 Sharon). Aerial photographs and satellite images, along with information from the school, identify that extensive additions were added in 1954, 1964, 1966, and 2000. The school is located south of the Town of Sharon and one kilometre from the highly populated City of Newmark.xlv  This is an institutional property.
Thematic Framework:	Social Development
Evaluation O. Reg. 9/06	This property meets two criteria of <i>O. Reg. 9/06</i> , including criteria 1 and 4.  It has physical value as a locally rare example of mid 20 <sup>th</sup> century modern architecture in Sharon. It has historical value as the site of a public school since 1858 and is an institution that is significant to the community.  However, even though it is connected to the village, the school property has a design that is very different from the general characteristics of the village.

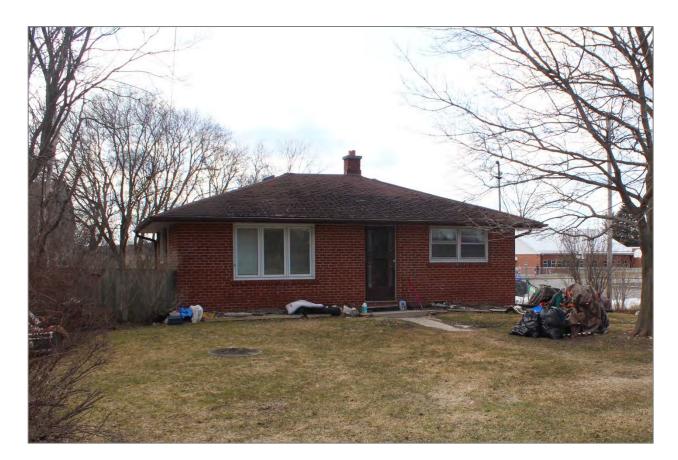
Property Name:	N/A
Roll Number:	N/A
Heritage Status:	N/A
Date:	1954-1960
Architectural Style /	Vernacular
Influence:	
Floorplan:	Square
Storeys:	1
Foundation:	Concrete
Main Exterior Walls:	Red brick
Roof:	Truncated hip, single stack chimney
Typical Window:	Rectangular, sash with soldier course
	sill
Main Entrance:	Off centre, flat, plain trim
Main Stairs/Porch:	1 concrete step
Other Buildings:	N/A
Landscape Features:	Mature deciduous trees to the
	northeast and southeast of the main
	house
Other Property	N/A
Features:

History	This property is on Lot 7 Concession 2. Between 1860 and 1878, William
Summary:	Kitely owned the property. This property appears to have been used as a field. Aerial photographs and satellite images do not show any buildings or structures on the property until 1970.
	This is a residential property.
Thematic	N/A
Framework:	
Evaluation	This property does not meet any of the criteria of O. Reg. 9/06.
O. Reg. 9/06

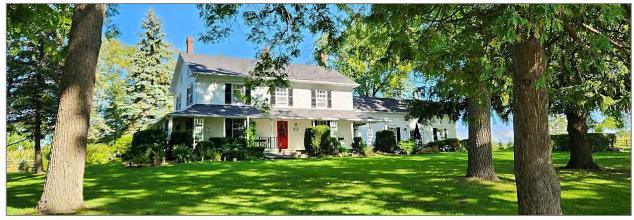
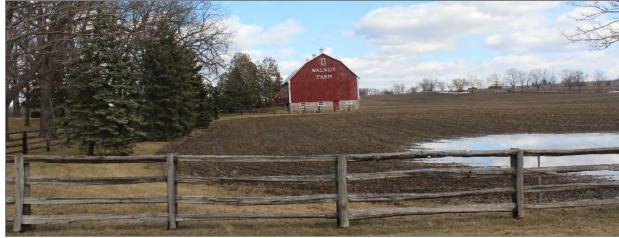
Property Name:	Walnut Farm
Roll Number:	1954-000-220-800-00
Heritage Status:	Listed, Section 27 Part IV
Date:	1857
Architectural Style /	Vernacular; Georgian
Influence:	
Floorplan:	Rectangular
Storeys:	2.5
Foundation:	Unknown
Main Exterior Walls:	Wood frame with clapboard siding
Roof:	Gable with red brick chimney
Typical Window:	Rectangular, sash with white trim
Main Entrance:	Unknown; center hall
Main Stairs/Porch:	Porch extends along the southeast and
	southwest elevations of the main
	building
Other Buildings:	Shed to the east of the main building;
	barn to the southeast of the main
	building; gazebo to the southwest of
	the main building
Landscape Features:	Agricultural fields, mature deciduous
	and coniferous trees line the property's
	driveway and are interspersed
	throughout the property
Other Property	White picket fence and gate
Features:

A log house was built on the property in 1830. The residence was built in 1857 by Judah Lundy, a member of the Children of Peace. Judah also took part in the 1837 Rebellion.

The wood for the house had been cut five years earlier and had to dry before construction took place. Named because Mrs. Lundy brought black walnut from Albany, Illinois when the family moved to Sharon. A black walnut tree was planted in the southeast corner of the lot. XIVI

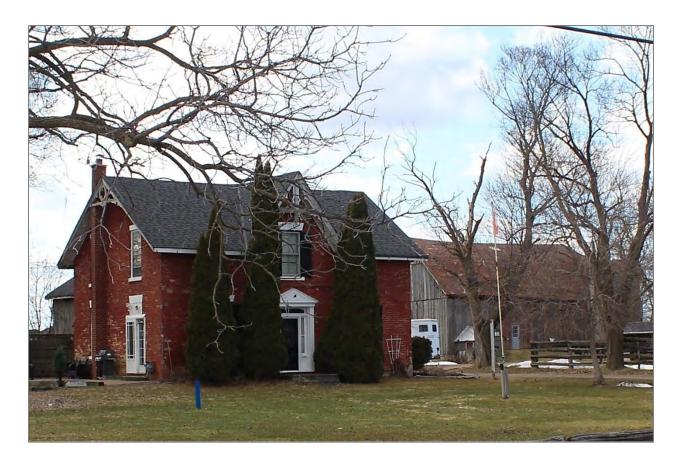
<b>Property Name:</b>	William Kitley House
Roll Number:	1954-000-220-057-00
Heritage Status:	N/A
Date:	1864
Architectural Style /	Vernacular, Gothic Revival
Influence:	
Floorplan:	Rectangular with a rear wing
Storeys:	1.5
Foundation:	Unknown
Main Exterior Walls:	Red brick
Roof:	Centre Gable, decorative trim in gable
	ends, single stack chimney
Typical Window:	Rectangular, sash, jack arch with brick
	voussoirs
Main Entrance:	Flat with sidelights and transom light,
	plain pediment trim
Main stairs/porch:	Concrete 2 step porch
Other Buildings:	Large barn and small stable, paddock
Landscape Features:	Cedar rail fence, lumber fence
Other Property	
Features:

History Summary:	The property has continuously operated as a farm. Aerial photographs and satellite images identify that by 2005, several livestock stables had been but	
	Also known as Morton Stables- known for breeding ponies.	
	This is a residential and agricultural property.	
Thematic Framework:	N/A	
Evaluation O. Reg. 9/06	This property meets two criteria of <i>O. Reg. 9/06</i> , including criteria 1 and 7. It has physical value as a locally representative example of a vernacular farmhouse with gothic revival and neoclassical influences.	
	It has contextual value because it supports the agricultural character of its surrounding area.	
	The agricultural character of this area is substantially different from the village.

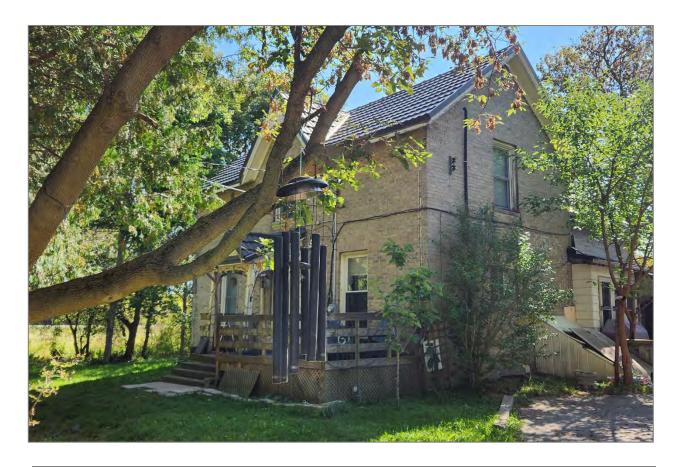
Property Name:	N/A
Roll Number:	N/A
Heritage Status:	N/A
Date:	1878-1926
Architectural Style /	Vernacular/Gothic Revival
Influence:	
Floorplan:	T shape
Storeys:	2
Foundation:	Stone
Main Exterior Walls:	Unknown
Roof:	Cross gable
Typical Window:	Unknown
Main Entrance:	Unknown
Main Stairs/Porch:	Unknown
Other Buildings:	Large barn
Landscape Features:	Mature deciduous and coniferous trees
	along the property line and surrounding
	the main house.
Other Property	
Features:

History Summary:	This property is on Lot 7 Concession 2. Between 1860 and 1878, William Kitely owned the property. Aerial photographs and satellite images do not show any major modifications to the property since 1927.  This is a residential and agricultural property.
Thematic Framework:	N/A
Evaluation O. Reg. 9/06	This property meets criteria 7 of <i>O. Reg. 9/06</i> .  It has contextual value because it supports the agricultural character of its surrounding area.  The agricultural character of this area is substantially different from the village.

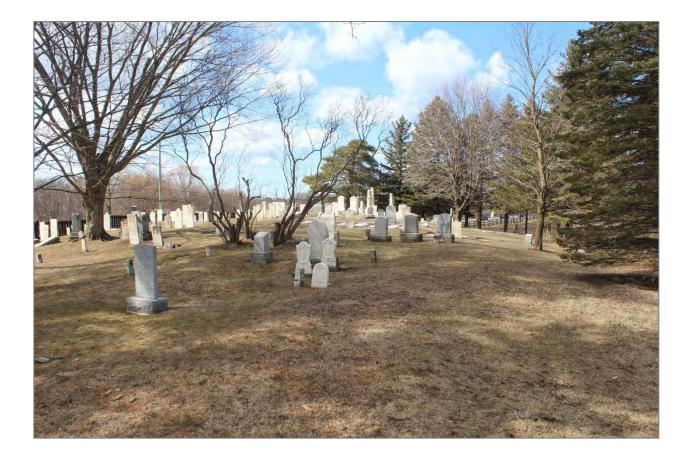
<del></del>
Property Name:	Old Burying Ground
Roll Number:	N/A
Heritage Status:	Designated, Section 29 Part IV
Date:	c. 1812. The first marked graves are
	from 1820 and the last are from 1935
Architectural Style /	N/A
Influence:	
Floorplan:	N/A
Storeys:	N/A
Foundation:	N/A
Main Exterior Walls:	N/A
Roof:	N/A
Typical Window:	N/A
Main Entrance:	N/A
Main Stairs/Porch:	N/A
Other Buildings:	N/A
Landscape Features:	Mature deciduous and coniferous trees
	interspersed throughout the property
Other Property	Grave markers; iron fence and gate.
Features:

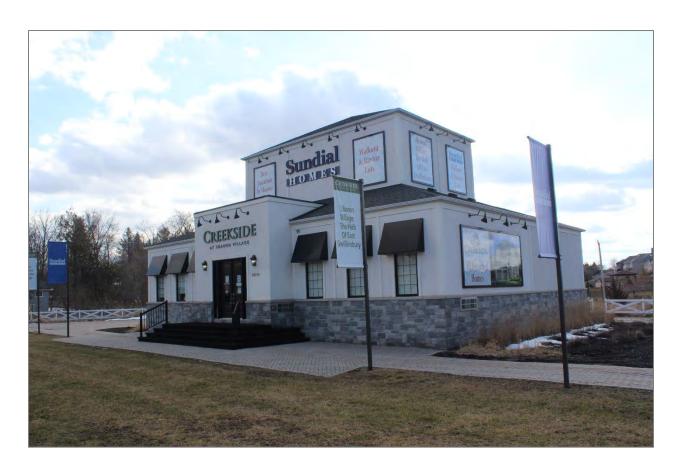
## Between 18716 and 18770 Leslie Street

-	
Property Name:	N/A
Roll Number:	N/A
Heritage Status:	N/A
Date:	2015
Architectural Style /	Vernacular
Influence:	
Floorplan:	Square
Storeys:	2
Foundation:	Unknown
Main Exterior Walls:	Frame with stone veneer and stucco
Roof:	Нір
Typical Window:	Fixed
Main Entrance:	Metal double leaf
Main Stairs/Porch:	Four steps lead to a platform in front of
	the main door.
Other Buildings:	N/A
Landscape Features:	Most of the lot is a parking lot on both
	sides and wraps around the back of the
	building.
Other Property	The area in front of the building is an
Features:	interlocking brick pathway

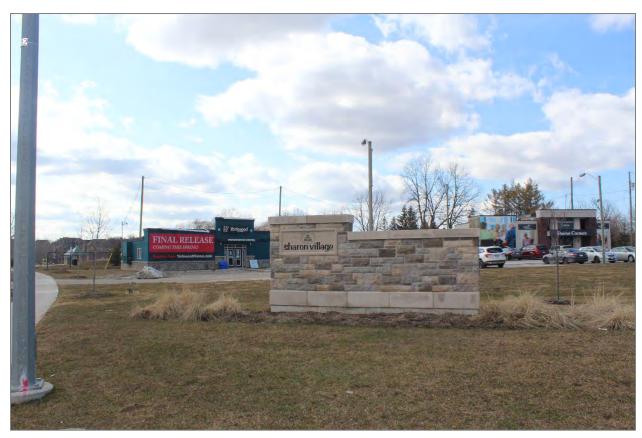
## **Northwest Corner Leslie Street and Manor Hampton Street**

1	
Property Name:	N/A
Roll Number:	N/A
Heritage Status:	N/A
Date:	2015-2021
Architectural Style /	N/A
Influence:	
Floorplan:	N/A
Storeys:	1
Foundation:	Unknown
Main Exterior Walls:	Frame
Roof:	Flat
Typical Window:	Unknown
Main Entrance:	Double leaf metal and glass doors
Main Stairs/Porch:	N/A
Other Buildings:	
Landscape Features:	Stone gateway feature with "Sharon
	Village" on it with a small garden in
	front.
Other Property	Gravel and asphalt parking lot
Features:

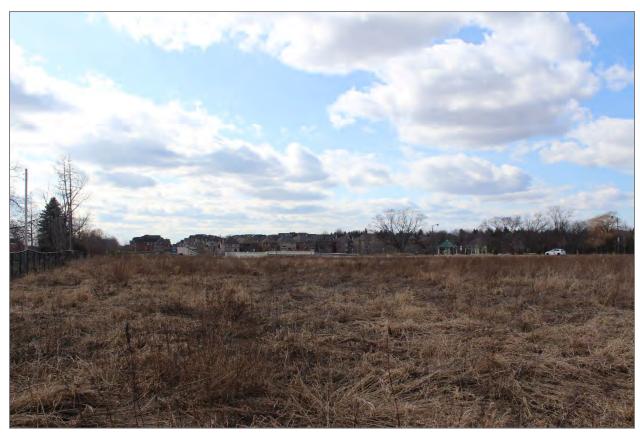
## **Southwest Corner Leslie Street and Manor Hampton Street**

<b>Property Name:</b>	N/A
Roll Number:	N/A
Heritage Status:	N/A
Date:	N/A
Architectural Style /	N/A
Influence:	
Floorplan:	N/A
Storeys:	N/A
Foundation:	N/A
Main Exterior Walls:	N/A
Roof:	N/A
Typical Window:	N/A
Main Entrance:	N/A
Main Stairs/Porch:	N/A
Other Buildings:	N/A
Landscape Features:	Open, grass covered lot
Other Property	N/A
Features:	
·

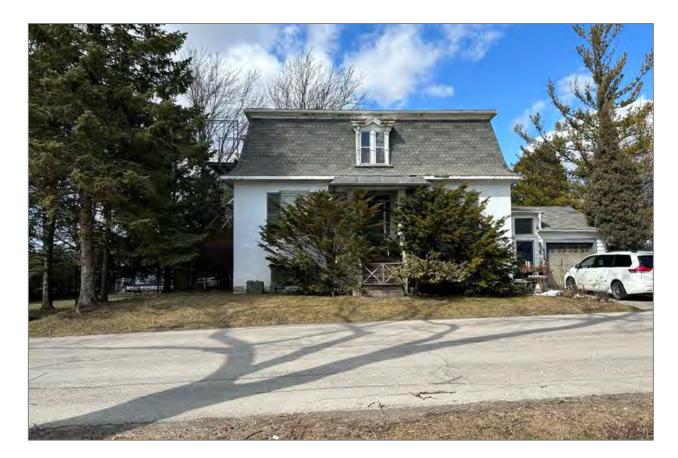
#### 4 Farr Avenue

Property Name:	Austin Titus Doan Farm
Roll Number:	1954-000-222-370-00
Heritage Status:	Listed, Section 27 Part IV
Date:	1860
Architectural Style /	Second Empire
Influence:	
Floorplan:	Rectangular with side wing addition
Storeys:	2
Foundation:	Stone
Main Exterior Walls:	Stucco
Roof:	Mansard
Typical Window:	Rectangular, sash with white trim and
	storm shutters
Main Entrance:	Flat, solid single leaf door with transom
	and sidelights; centre hall
Main Stairs/Porch:	Central porch centrally located on the
	primary south elevation
Other Buildings:	N/A
Landscape Features:	Mature deciduous and coniferous trees
	extend along each property line; shrubs
	in front of the porch
Other Property	N/A
Features:

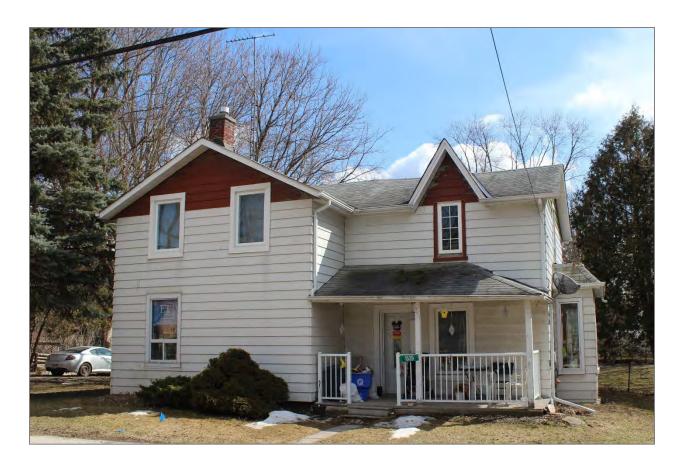
## 1529 Mount Albert Road

Property Name:	Wilson Reid House, Reuben Phillips House
Roll Number:	1954-000-221-986-00
Heritage Status:	Listed, Section 27 Part IV
Date:	1860-1876
Architectural Style / Influence:	Classical Revival, Vernacular
Floorplan:	T shaped with rear wing addition
Storeys:	2
Foundation:	Unknown
Main Exterior Walls:	Aluminum siding
Roof:	Cross gable
Typical Window:	Rectangular, sash window with plain wood trim
Main Entrance:	Flat, single leaf door with central glazing
Main Stairs/Porch:	Wood 2 step porch covered by a gable roof supported by Doric columns
Other Buildings:	N/A
Landscape Features:	Mature coniferous trees line the northeast, southeast, and southwest property line
Other Property Features:	N/A
